**Aircraft, Maritime and Railway Accident Investigation Directorate
Maritime Accident Investigation Unit**

FINAL REPORT

**Investigation of a very serious marine accident –
DEATH OF A CREWMEMBER IN A FALLING IN THE CARGO
HOLD OF M/V ANNA M, 2014**

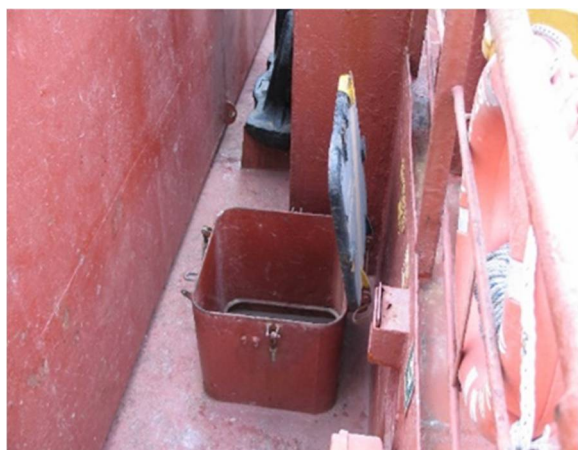
Entry into the hold No. 1 is made from the upper deck - starboard side, through the entrance hatch/**Fig. 2, Fig. 3**/, mounted on a 60 cm high coaming. A handle is welded inside the coaming to provide support in case of using the ladder . The entrance is designated as a restricted area.

Fig. 2 Entrance hatch – cargo hold № 1

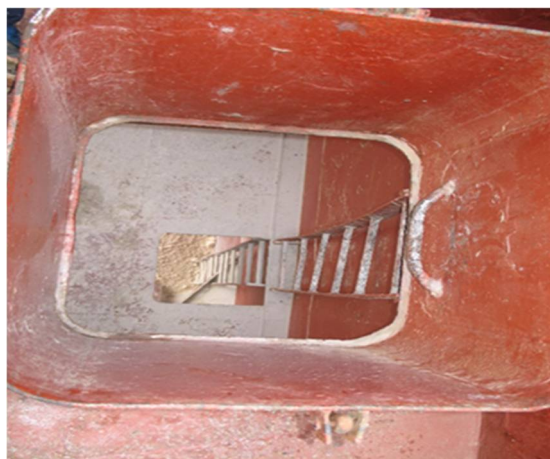
Fig. 3 View from the entrance hatch to the vertical ladder

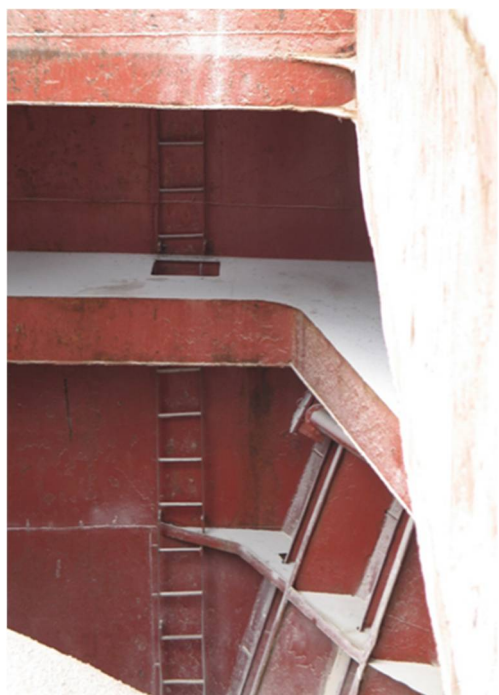
The vertical ladder /**Fig. 4**/ for descent into hold No. 1 is located on the right side of the bow bulkhead of the hold. The ladder has a total height of 6.5 m and consists of three parts, firmly attached to the bow bulkhead of the hold. The upper part of the ladder leads to the platform of the twin deck, at a height of the floor 4.5 m. The middle and the lower part of the ladder are separated by a horizontal full frame of the bulkhead, part of the structural framing of the ship, at a floor height of 2.5 m. The ladder is without safety rails or brackets. The steps of the upper part of the ladder are metal rods with circular cross section, highly corroded and do not provide good grip, especially when wet or when using gloves. The ladder itself in this part is deformed. The middle and bottom part of the ladder are in good condition and their steps are square-sectioned metal rods.

Fig. 4 View of hold № 1 and the vertical ladder.

2. Slipping, tripping, loss of grip on wet steps, etc.
3. The structural layout and poor condition of the vertical ladder in cargo hold №1, which requires caution when using it.

Immediately after the accident, the ship owner AB DENIZCILIK VE TICARET LTD undertook a set of measures aimed at preventing, minimizing and eliminating the risks of such incidents. The upper part of the vertical ladder for entry into cargo hold No.1 had been replaced.
