REPUBLIC OF BULGARIA
NATIONAL AIR, MARITIME AND RAILWAY ACCIDENT INVESTIGATION
BOARD

FINAL REPORT

THE INVESTIGATION OF A SERIOUS MARITIME ACCIDENT –

Grounding of the motor vessel „LOYGA“ on 17.02.2023

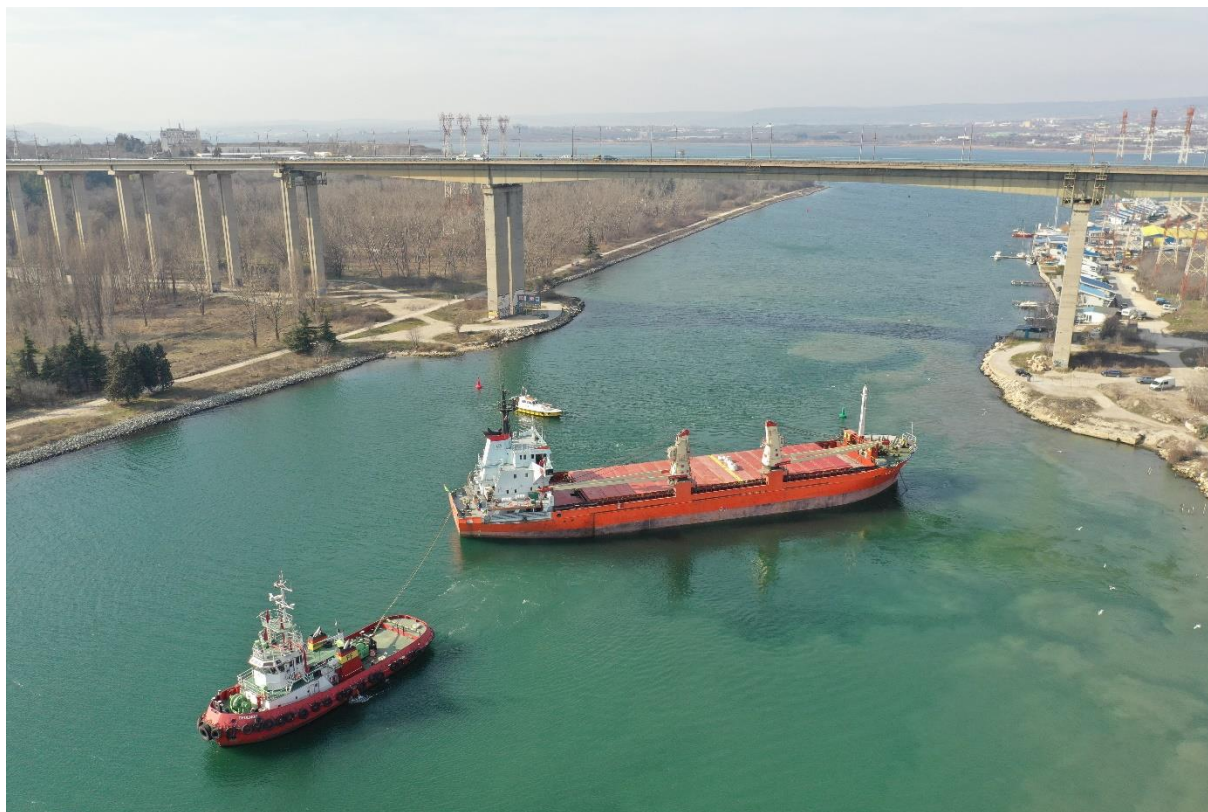
Figure 1 – Motor vessel „LOYGA“ at the place of grounding (Photo courtesy Sky Pictures Bulgaria)

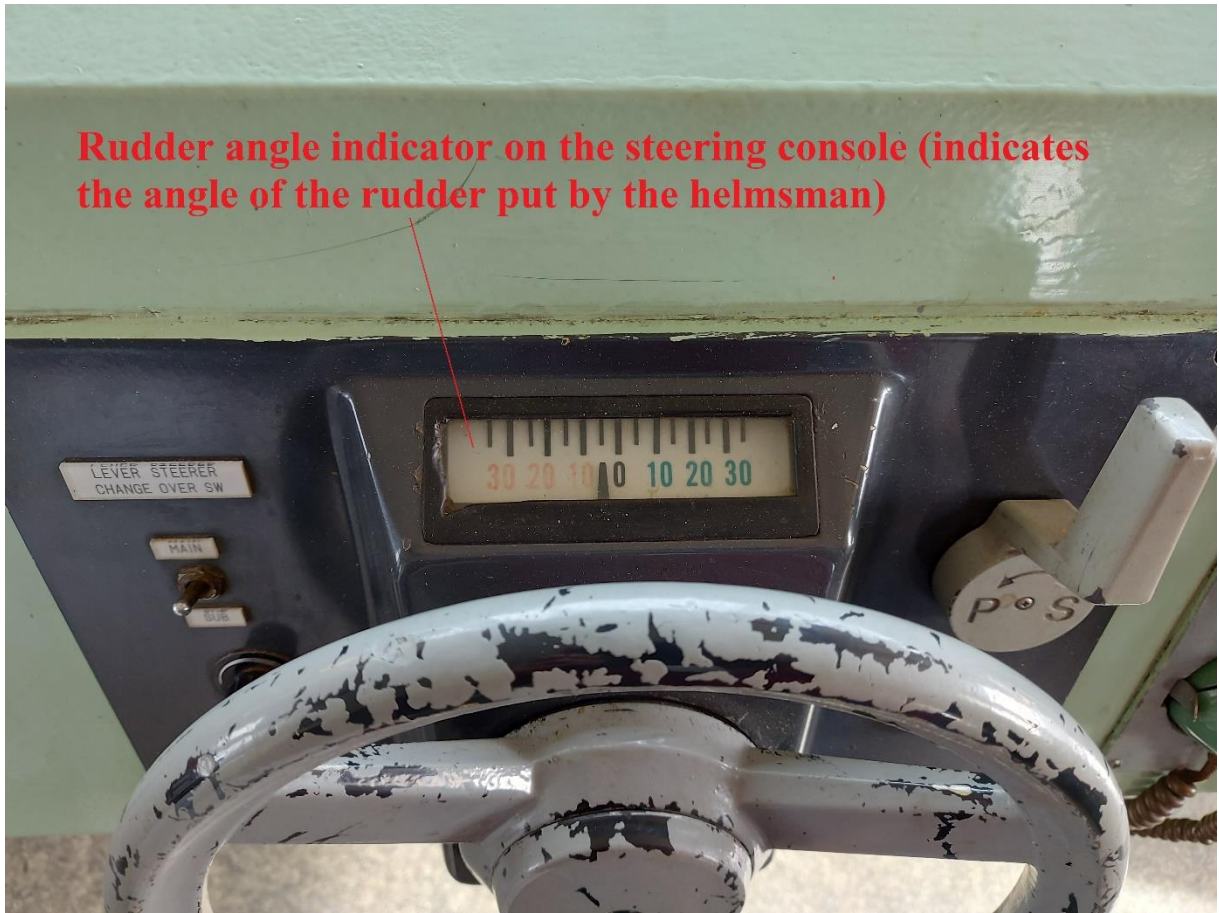
The steering rudder angle indicator was located at the steering console in front of the helmsman (figure 5).

Rudder angle indicator on the steering console (indicates the angle of the rudder put by the helmsman)

Figure 5 – Rudder angle indicator on the steering console

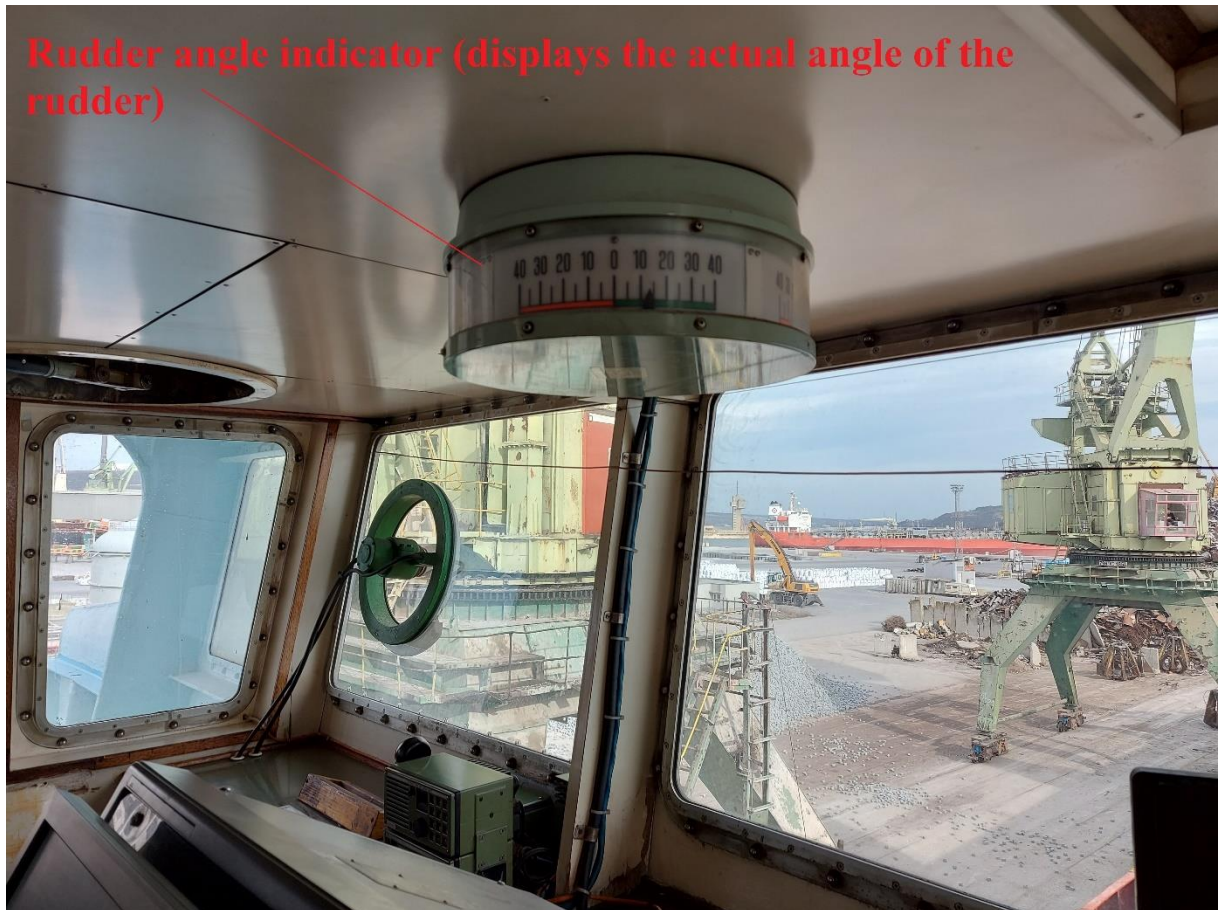
On the bridge ceiling there was a circular rudder angle indicator of the actual instantaneous position of the rudder (figure 6). The indicator was positioned in the way that allows observations to the left and right of the rudder. The pilot and the master were watching this indicator.

Rudder angle indicator (displays the actual angle of the rudder)

Figure 6 – Rudder angle indicator on the bridge ceiling

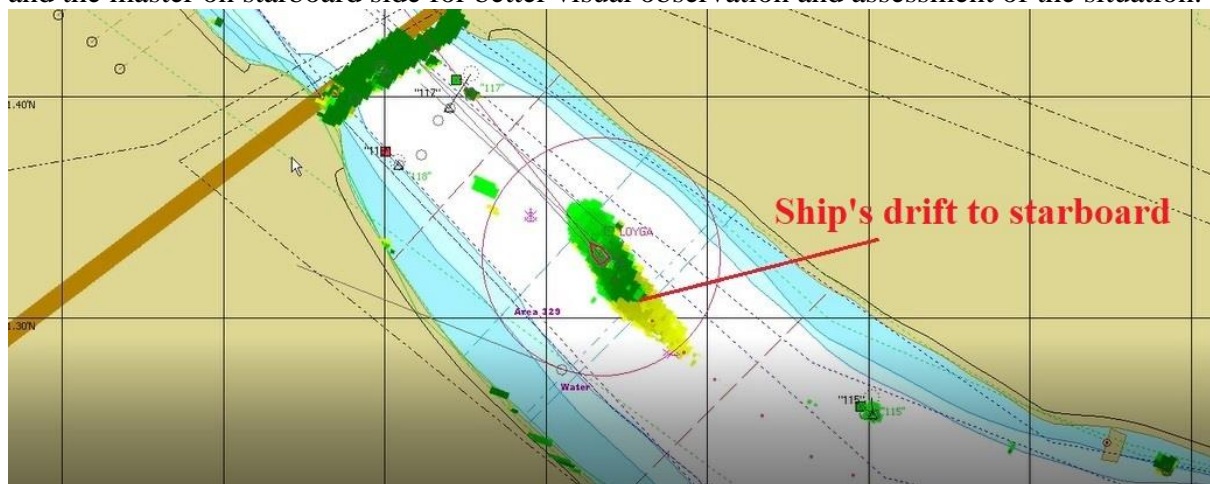
When approaching buoys 117-118, the pilot noticed the ship was slightly drifting from the desired line to starboard (figure 7). At this point, the pilot was on the port side of the bridge, and the master on starboard side for better visual observation and assessment of the situation.

Figure 7 – Radar image showing the ship’s drift to starboard (points behind the ship are her past track)

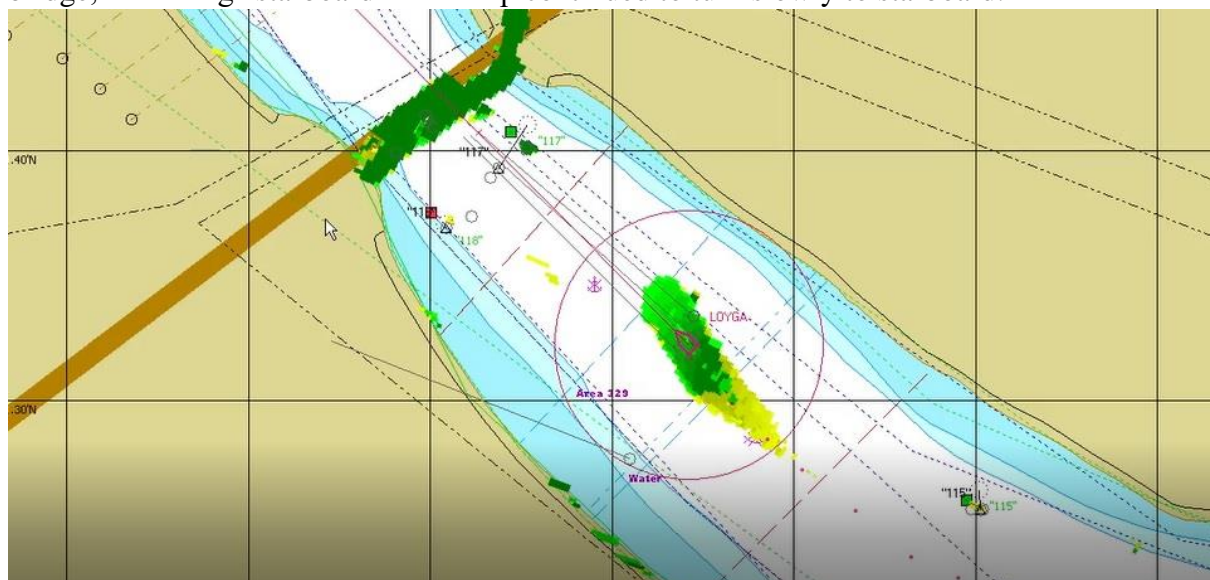
In order to correct the drift to starboard, at approximately 12:56:03 (figure 8), the pilot ordered “Port 10”. Seeing that the bow of the ship was turning to the starboard instead of turning to port, the pilot ordered “Port 20” and looked at the rudder angle indicator on the ceiling of the bridge, indicating “starboard”. The ship continued to turn slowly to starboard.

Figure 8 – Position of the vessel at the time of ime of the command "Left 10" given by the pilot

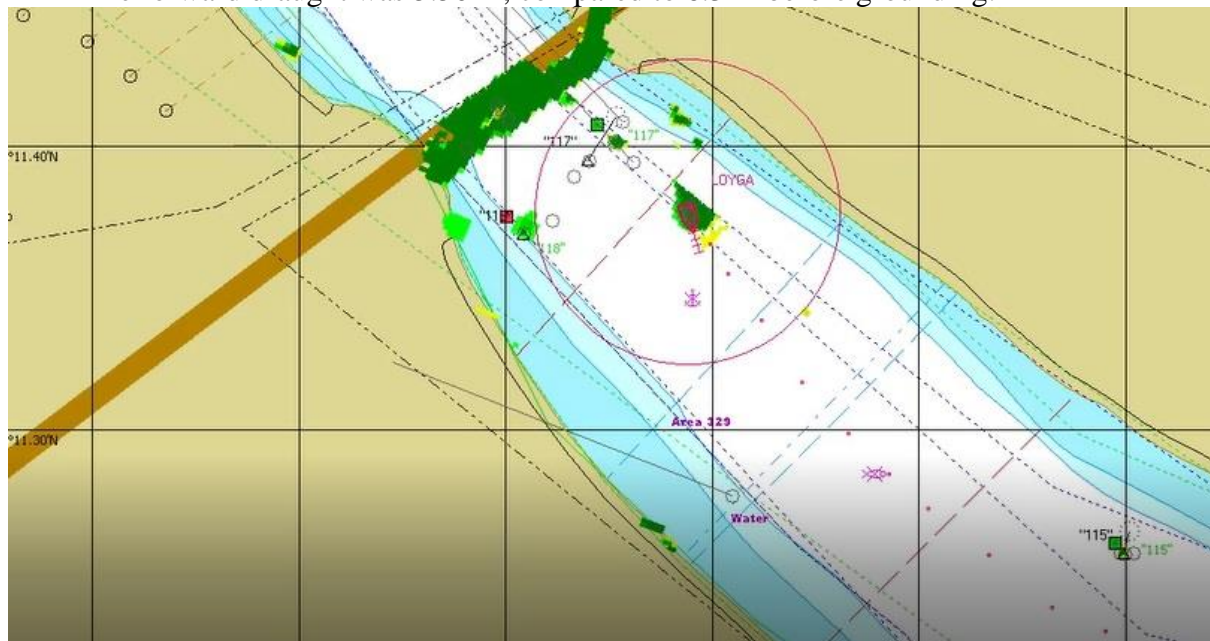
The ship grounded at 12:57:05 at about 50 meters NE of buoy No 117 (figure 9).

Figure 9 – Radar image of the motor vessel „LOYGA“at the place of grounding
