**Aircraft, Maritime and Railway Accident Investigation Directorate  
Maritime Accident Investigation Unit**

**FINAL REPORT**

**Investigation of very serious marine casualty –**

**FIRE IN ENGINE ROOM AND DEATH OF A CREW MEMBER OF  
*M/V „KARADENIZ 5“ ON 14.08.2018***

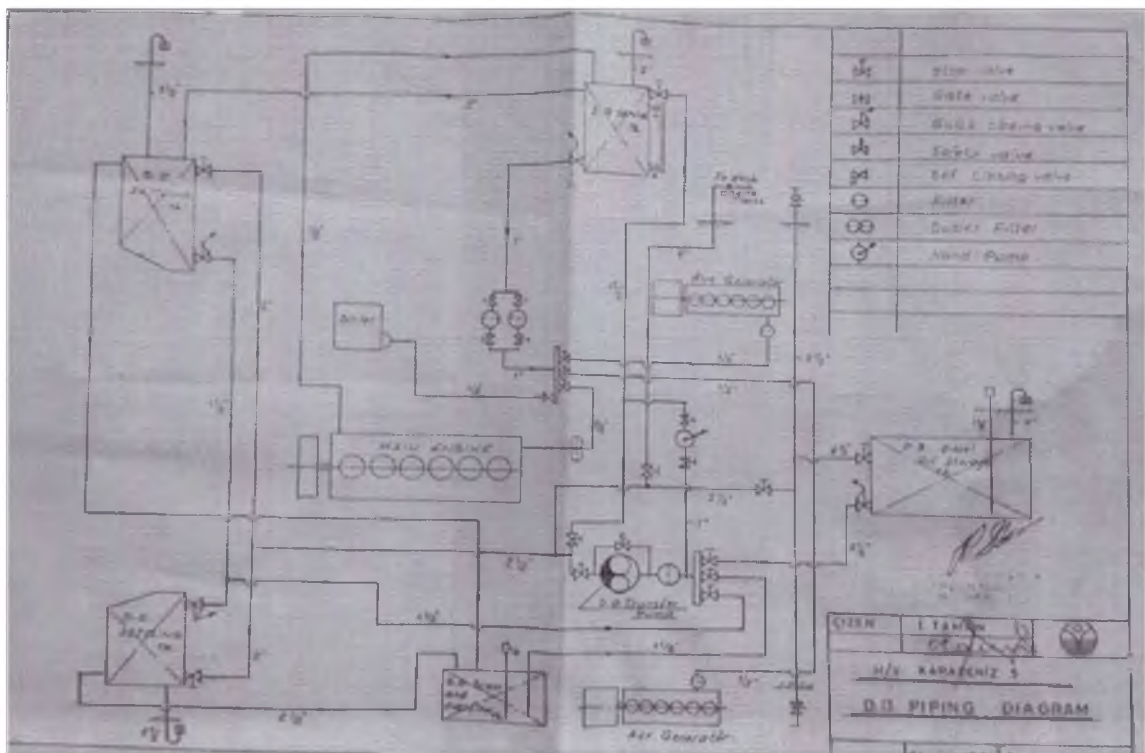
**Fig. 1**

- The original design of the fuel oil system according to the scheme (Fig. 1) shows the individual tanks, mechanisms and piping connections between them. On this scheme, the following can be seen and noted:
- D.O. settling tanks and D.O. service tanks have vent pipes with exits on the main deck;
- D.O. service tanks overflow pipes are directly connected to D.O. settling tanks;
- D.O. settling tanks overflow pipes are connected to a diesel fuel drain tank (D.O. drain tank).
- Fuel oil tanks are not equipped with level switches or sensors for an automatic shutdown of the fuel oil transfer pump when reaching a certain level in the tanks.

**6.1.** The ship's fuel system to be restored in accordance with the initial design, as for this purpose:

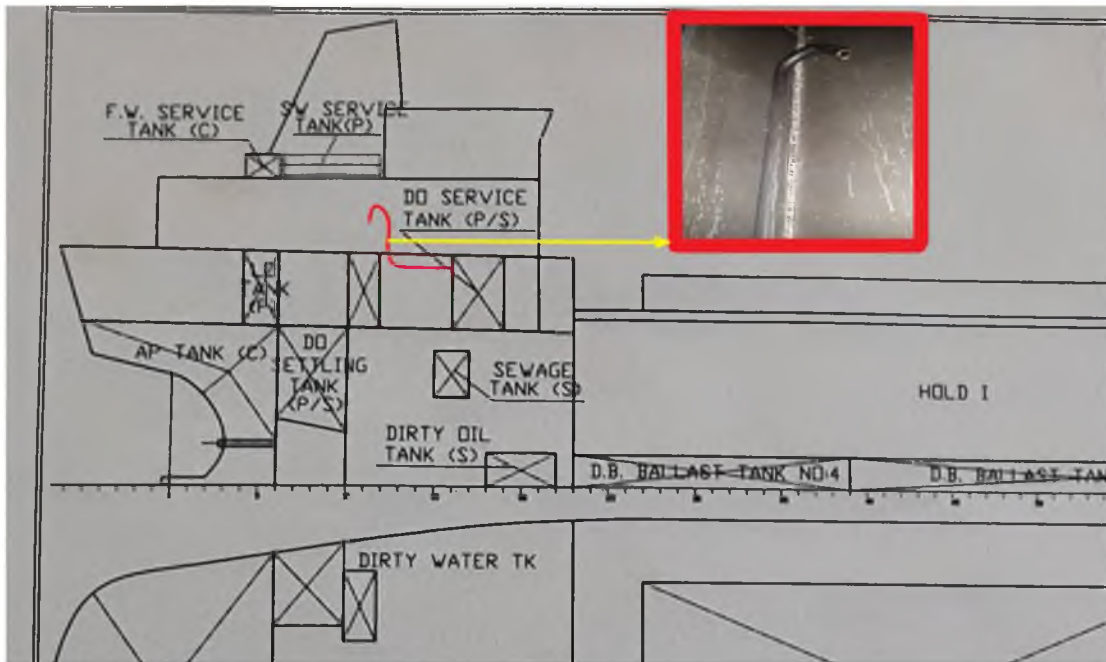
**Fig. 3**

began to overflow through the pipe in the ER. (**Fig. 3**) onto the M.E., and thence into the bilge space. Falling on the hot parts of the main engine, especially onto the turbo-compressor area, part of the fuel evaporated, mixing with the air in the ER. The engine flywheel is covered with a protective casing with holes for the engine manual rotation lever. A part of the fuel falling on it, by the action of centrifugal forces, had been sprayed onto the inside of the casing and through the holes in the casing extends outwardly in the form of a dispersion. As a result of this, a flammable fuel-air mixture was formed in the engine room, mainly in its stern part and the funnel area. By 2130, after leaving the captain, the chief engineer had gone down to the ER. While he was inside the engine room, this fuel-air mixture had ignited by the contact with non-insulated parts of M.E. exhaust system or from a spark from the collector brushes of the engine shaft generator. As the engine shaft generator was the only mechanism with serious fire damages and taking into account the blackout, the commission came to a conclusion that the ignition had been most likely caused by sparks in its collector brushes. Such sparks are typical for such type of electric machines. The ignition and combustion of the generated fuel-air mixture had an explosive character, it had proceeded at high speed, temperature and upward direction of the smoke in the rear part of ER. This resulted in a damage to the engine shaft generator, partial damages to MSB and a blackout. As a result of the blackout the electrical power supply to the electric consumers was impossible and had led to the suspension of the operating till the moment ones. This also stopped the operation of the fuel oil transfer pump. At the same time the fuel flow through the "vent pipe" from D.O. service tanks had stopped. As a result, the possibility of continuing evaporation, further formation of flammable mixture and combustion of diesel fuel was reduced.

The main cause that led to the very serious casualty (fire and death of a crew member) was the fuel oil spilling from the D.O. service tanks through the non-standard overflow pipe inside the ER. Its construction differs from that provided in the original design of the fuel oil system.

- a new inspection of the overflow pipelines connection point (from D.O. service tanks) and its possible change as it is under the project.

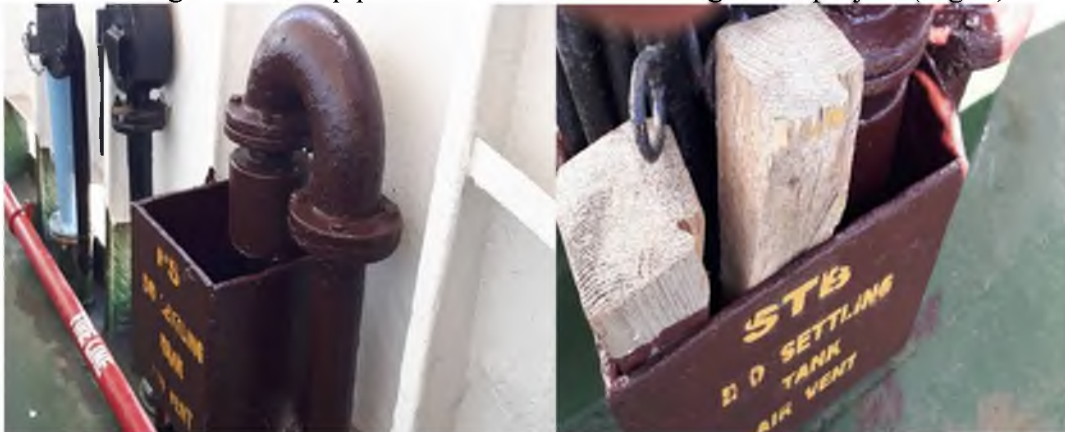
**Fig. 4**

- D.O. settling tanks vent pipes were mounted according to the project (**Fig. 4**)

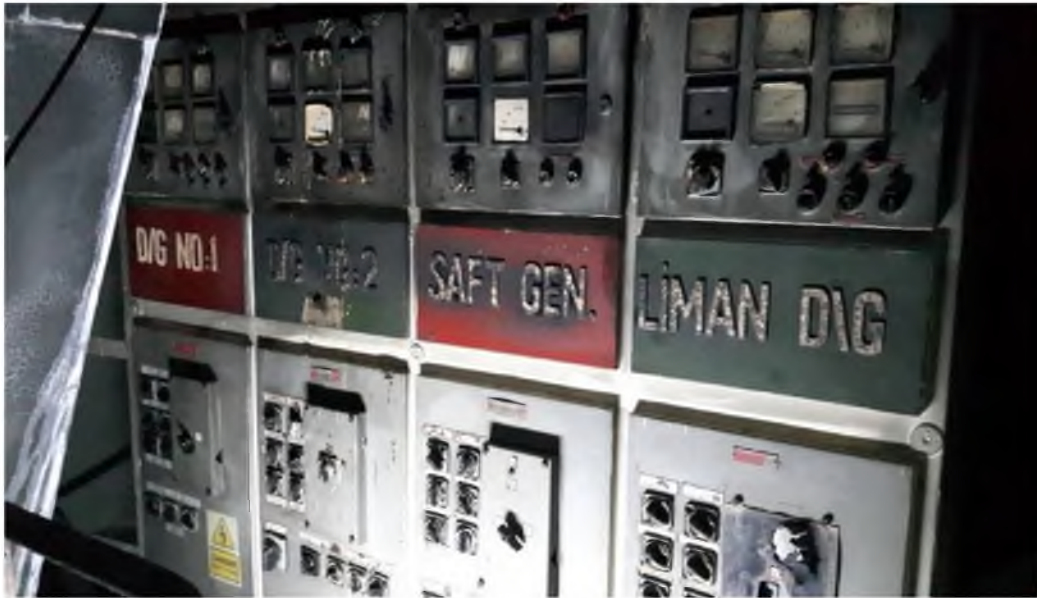
**Fig. 6**

During the inspections attention was paid to the status of the electrical system. The main switchboard consists of 4 sections: section of diesel generators №1 and № 2, the port diesel generator and the shaft generator. All sections were switched to zero position which meant that whatever had been electrically powered until the time of the accident was manually switched off by the crew subsequently (**Fig. 6**)

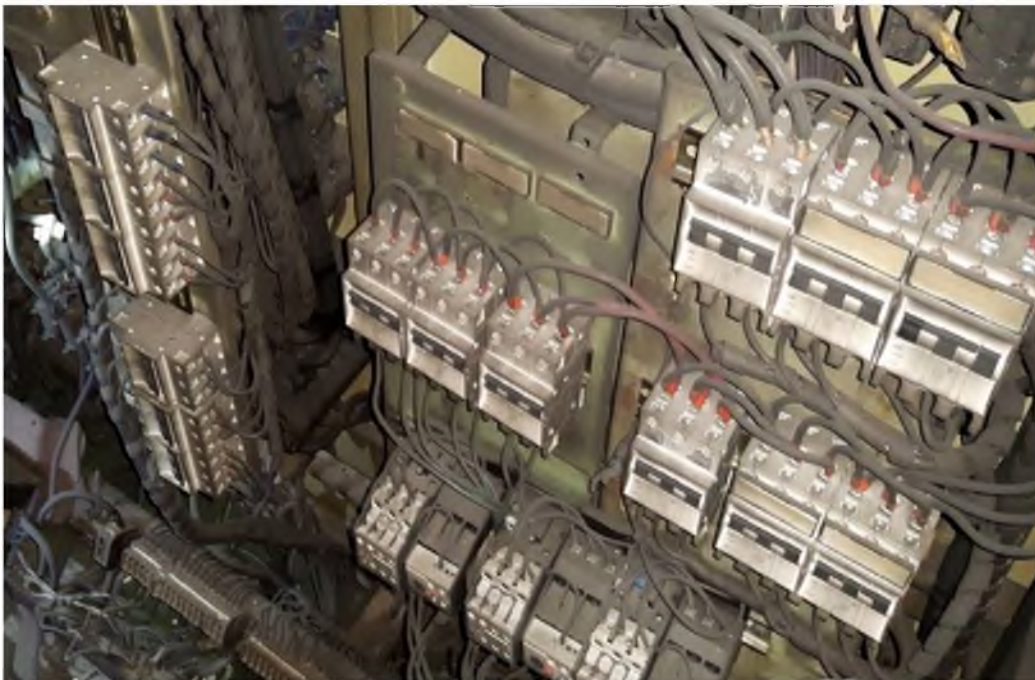
**Fig. 7**

No serious damages or traces of short-circuits in the control and measuring installations were found on the main switchboard (**Fig. 7**)

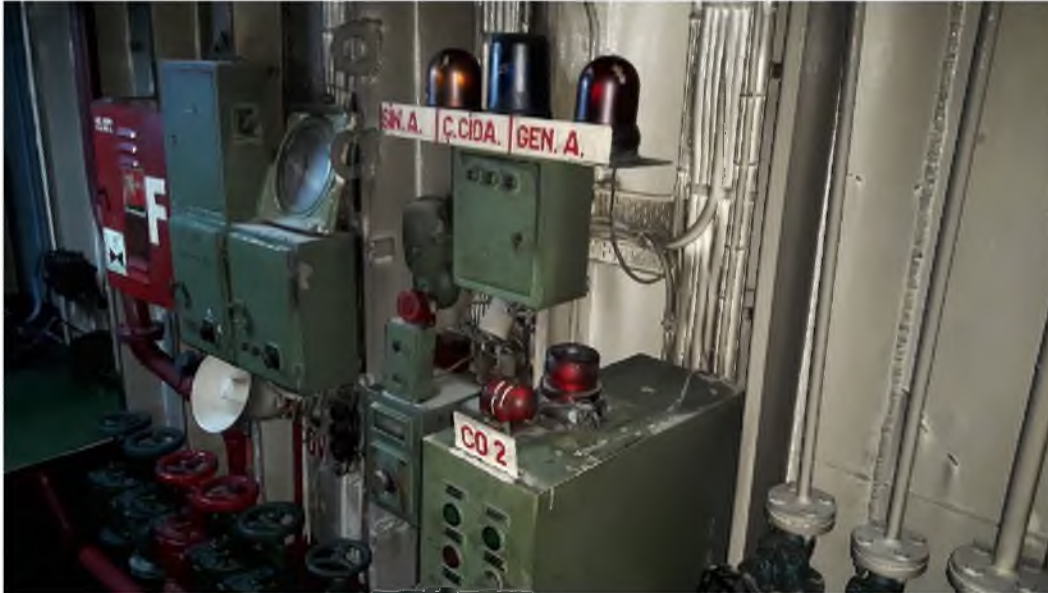
**Fig. 8**

**Fig.8** shows the emergency signaling system, warning the staff in the ER when starting the stationary CO<sub>2</sub> fire extinguishing system. The external view did not indicate any damages to the signaling system.

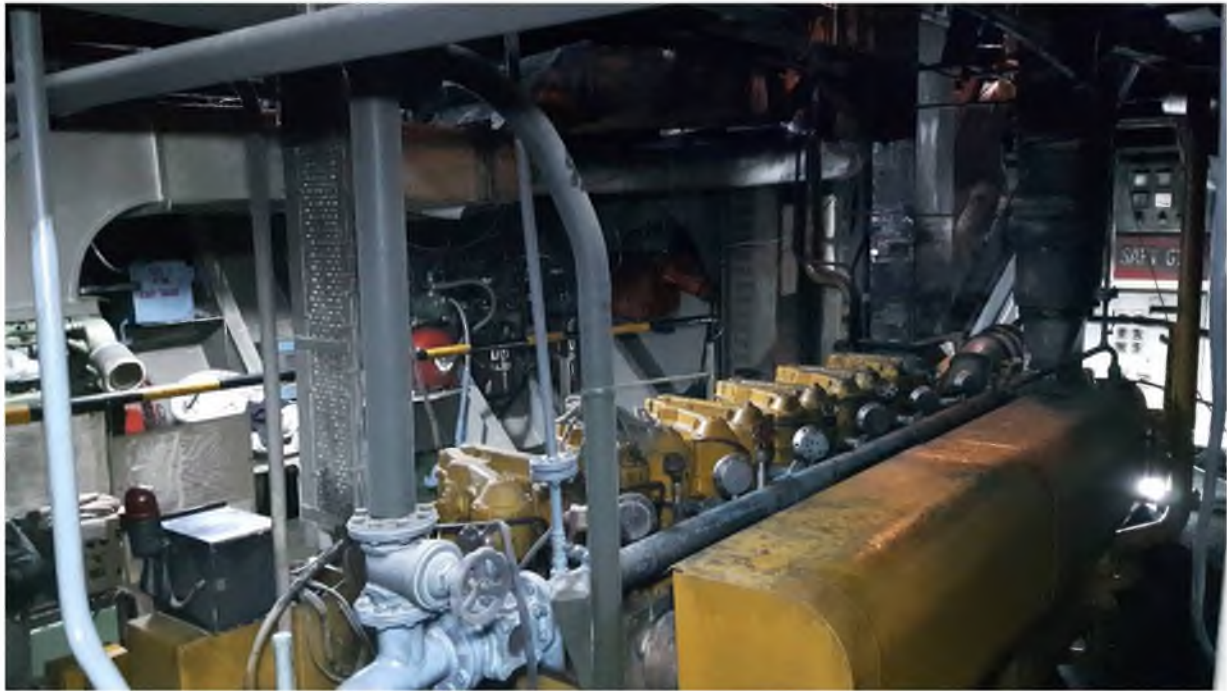
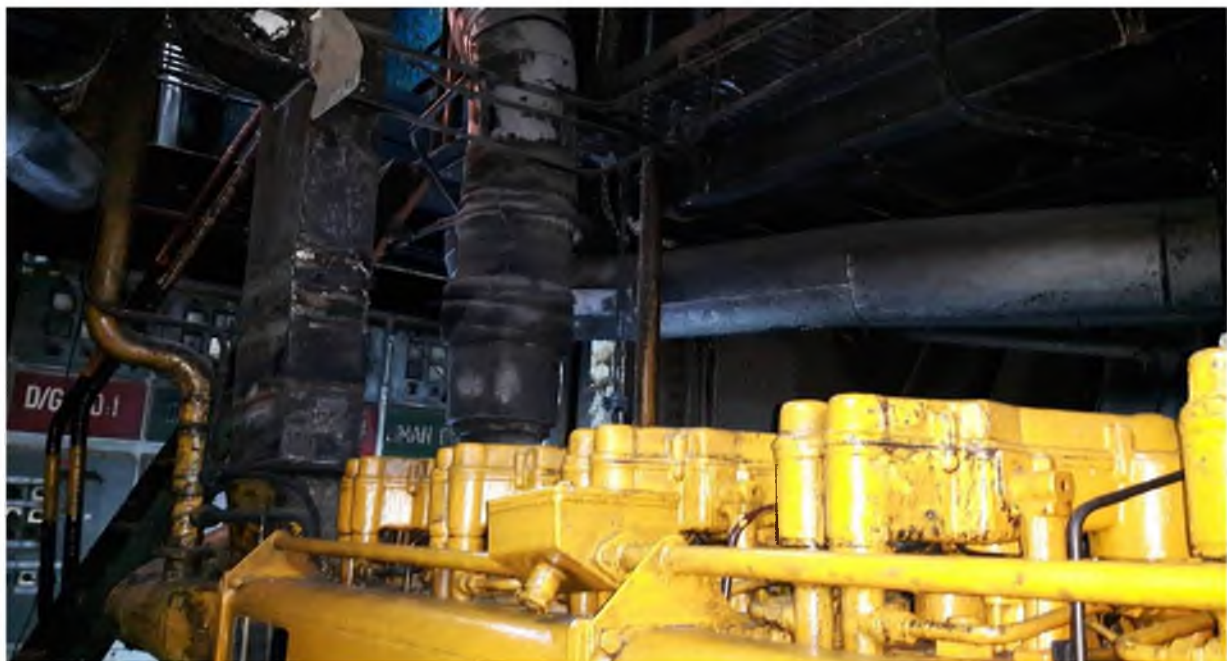
**Fig. 9**

During the inspections no residues of combustible materials were found which could have been in ER before the fire. It is particularly characteristic that the main damages and traces from the fire are located at the rear part of ER, near the entrance and the lower part of the funnel. They were visibly located from the platform on the 2nd level on which various auxiliary mechanisms are mounted and up to the funnel (**Fig. 9**). These auxiliary mechanisms such as diesel generators, boiler, compressors and others had no damages by the fire.

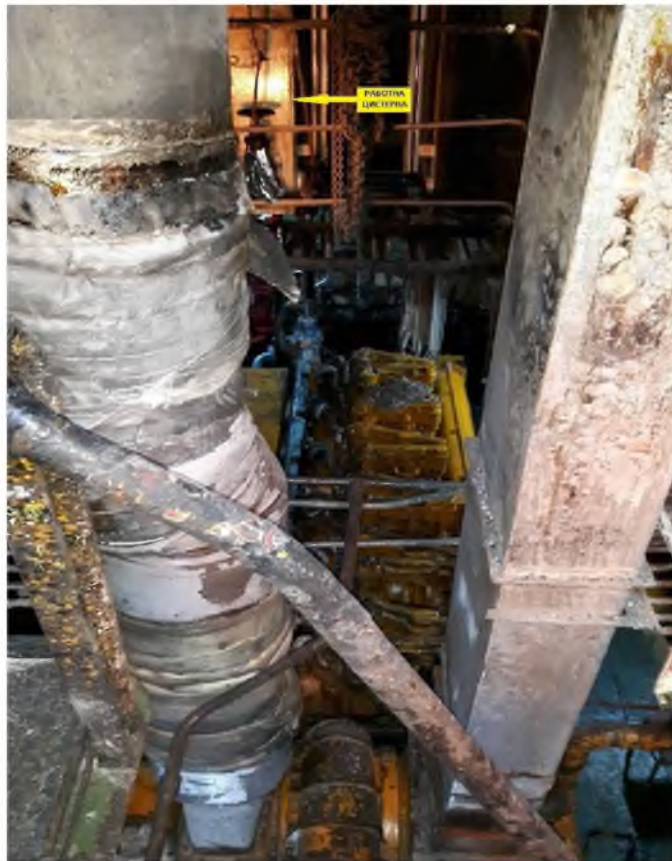
**Fig. 10**

On 14.08.2018, *m/v "KARADENIZ 5"* sailed from Constanta port to Marmara Island. Around 2100 the captain and the chief engineer were in the messroom. Based on an analysis of the collected information and facts (forensic expertise, testimonies of eyewitnesses, etc.) the commission considered that, when mounting watch, the chief engineer had started the fuel oil transfer pump to transfer diesel fuel oil from D.O. settling tanks to D.O. service tanks. Due to he had left the ER and gone to the messroom, no one directly observed the fuel level in D.O. service tanks. Due to the structural changes in the fuel oil system, the fuel from D.O. service tanks located above M.E. (**Fig. 10**),

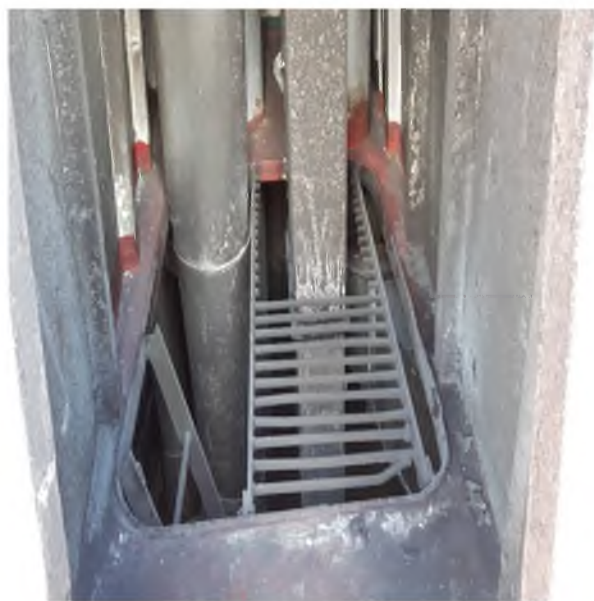
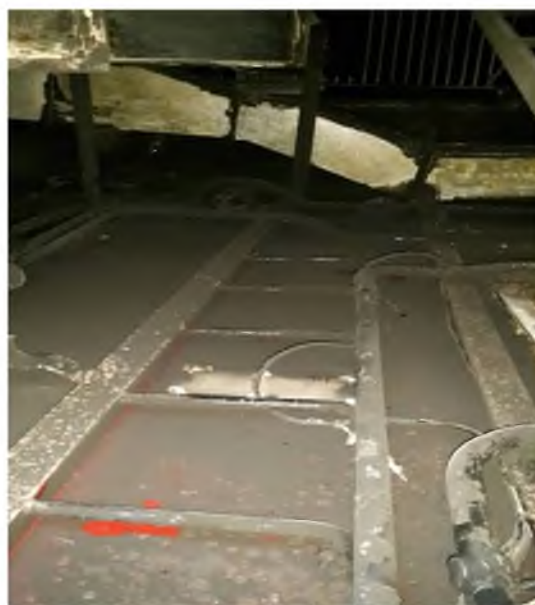
**Fig.11**

**3.2.2** As an aggravating circumstance for the death, it could be pointed the location of the emergency exit of the ER. (**Fig. 11**). In cases of fire in engine rooms, which happen relatively often, the crews must be able to safely leave the ER. The basic routes requirements for evacuation from the ER are pointed in SOLAS-1974 Convention, as amended. Detailed

2) a steel ladder leading from the lowest level of the machine space to the exit at the top of the room providing access to the deck and additionally at a location away from the entrance of such a ladder resulting in a safe escape route from the lower part of the engine room to the open deck. Exemption from the requirement for two evacuation exits from ER. shall apply to small crafts with a gross tonnage of less than 1 000 tonnes, taking into account the width and shape of the upper section of the engine room. Administration may also exempt cargo ships with gross tonnage below 1 000 tons, from the duty to protect with a fire barrier the steel ladder leading to the exit in the upper part of the engine room. *M/v "KARADENIZ 5"*'s gross tonnage is 996 t, i.e. it does not formally fall under the requirements of p.1. In this case, the emergency exit starts at the base of the main ladder at the entrance of ER and goes through the funnel on the upper deck. In fact, the two ladders are located very close, even connected at entrance of the ER. This makes it almost impossible to use such an emergency exit in an event of a fire or the development of the fire in the rear part of ER in the funnel area, as had happened in practice. To a greater extent, its function is mainly related to the maintenance and operation of the ship rather than its role as a real emergency exit.

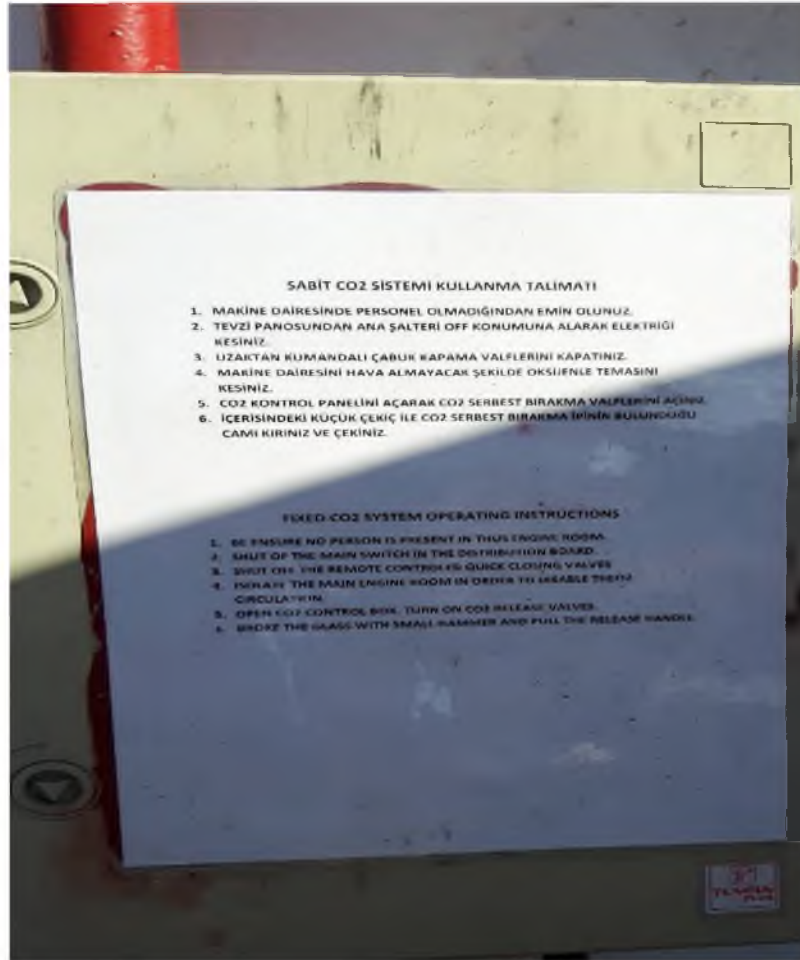
Fig. 12

It is clearly stated what actions and in what sequence they must be performed before the system to be started. The first and most important of them (point first) is to check for the presence of people in the ER. (**Fig. 12**).

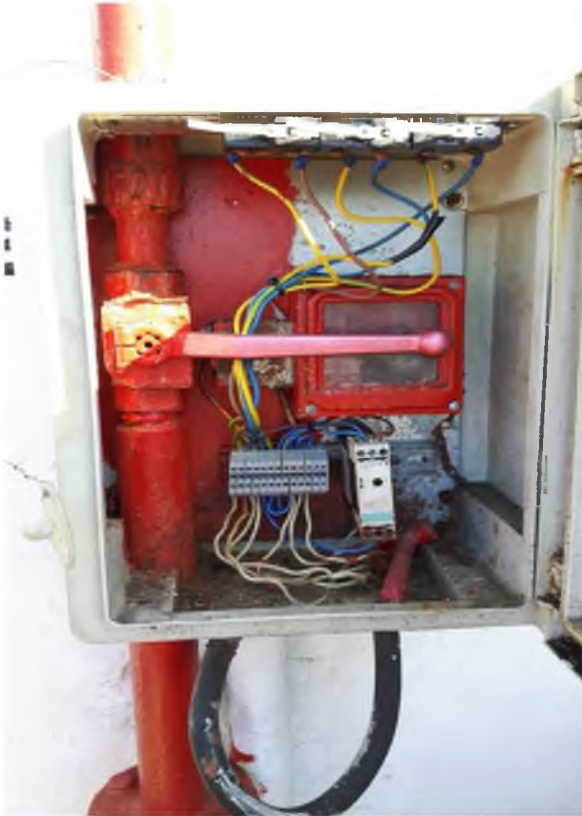
**Fig. 13**

The system design requires the standard starting procedure to be carried out by pulling out the handle in the CO<sub>2</sub> release box. The box is protected by a glass cover to avoid unplanned or wrong actions (**Fig. 13**). This handle is connected to the actuators (levers) of the valves mounted on the CO<sub>2</sub> bottles by a thin wire. These bottles, a total of 5 pieces, are located in a separate room in an immediate vicinity of the release box. (**Fig. 14**). After breaking the glass cover with a small hammer, pulling the handle with subsequent opening of the cylinder valves it becomes possible the gas to enter in the ER. Point six of the instructions said namely this. In the picture, however, it can be seen that the glass cover of the case is whole and intact.

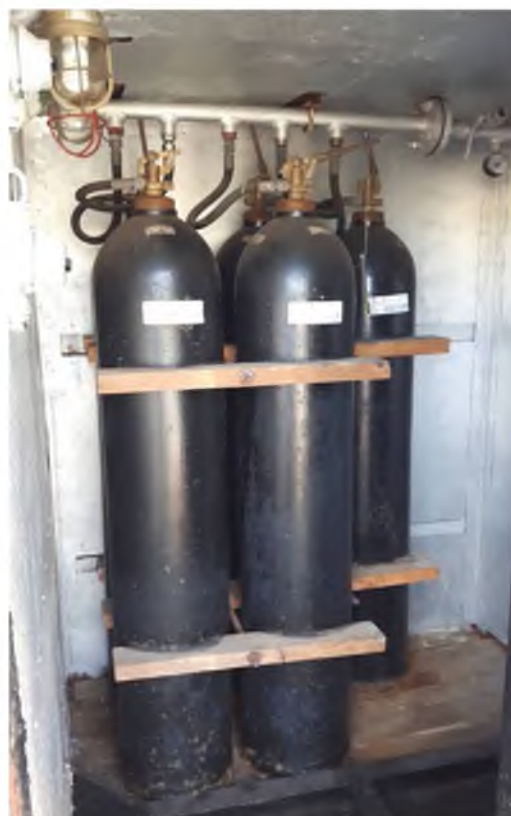
**Fig. 14**

It also impresses with the different position in which the CO<sub>2</sub> cylinder valve actuators themselves are located. On three of them, the actuators' levers are in the vertical position, i.e. the cylinder valves are in the closed position. On the other two levers are rather horizontal, one of them even hanging on the cord separately from the bottle.

- the procedure for starting up the  $\text{CO}_2$  system had not been followed as instructed;
- the crew manually opened only 2 of the 5  $\text{CO}_2$  gas cylinders' valves;
- the strength of the fire had decreased to a greater extent due to the combustion of the already formed fuel-air mixture than by the impact of  $\text{CO}_2$  gas;
- non-compliance with the instructions for  $\text{CO}_2$  system use was not a determining major factor for chief engineer's death;
- their actions during the fire had been somewhat chaotic.

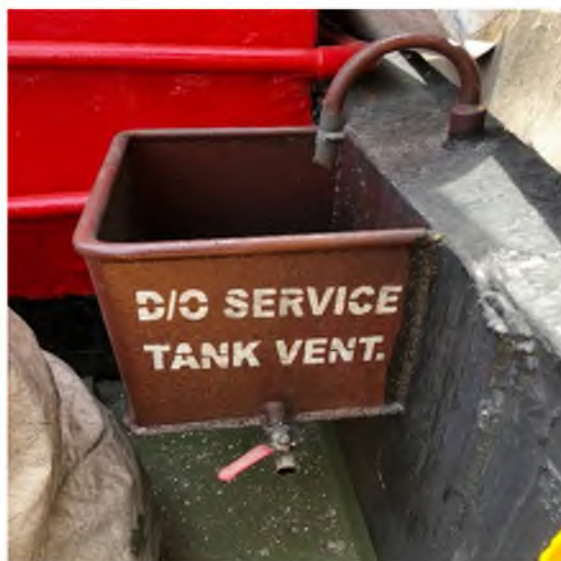
1. ship repair works had been carried out, generally including:
  - a repair of the shaft generator for electric power;
  - a main engine turbo compressor repair;
  - a reconstruction of main switchboard and lighting in ER.;
  - cleaning and painting in ER.
2. a new vent pipe was installed to D.O. service tanks at the place of the existing one,

(Fig. 15), which has not appropriate to ship's design.

- an installation of a standard vent pipes for D.O. service tanks (such as those of D.O. settling tanks). The pipe on **Fig. 15** can be considered as a temporary solution;
