**AIR, MARITIME AND RAILWAY ACCIDENTS INVESTIGATION
NATIONAL BOARD**

FINAL REPORT

Investigation of a serious railway accident - derailment of a freight train № 80561 in the entrance switches of Nova Zagora station on 15.05.2020

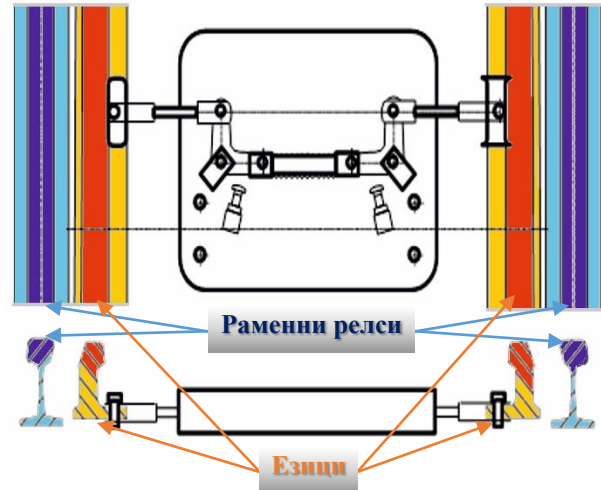
Fig. 3. Diagram of a spring rocker arm in equilibrium position

Fig. 2. Switch №20 spring rocker arm, set in unregulated (equilibrium) position

3. Recommendation 3 proposes NRIC together with Voestalpine Railway Systems Bulgaria OOD to amend and supplement the "Manual for installation, operation and maintenance of a spring rocker arm with two arms", to write down the parametric data for repair and maintenance in compliance with the norms for railway switches safe operation.

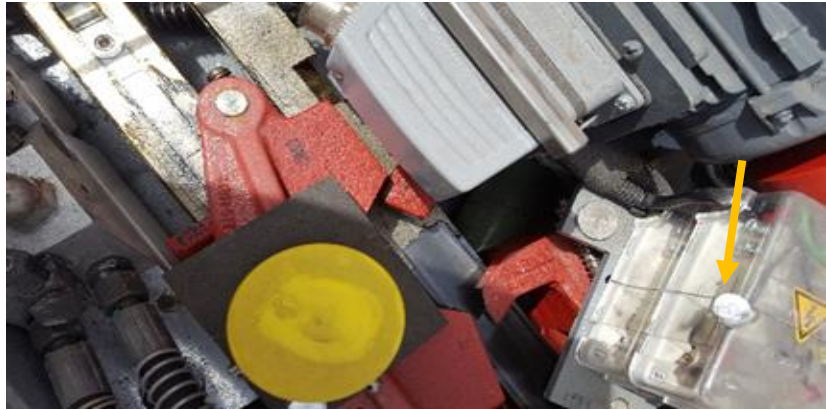
Fig. 41

After opening the EPM cover of switch № 20, it is found that there is no end position control due to a mismatch in the position of the actuator, which is in the extreme plus position, and the switch tongues are turned to the (minus) position. The electronic units are sealed with lead factory seals (Fig. 41).

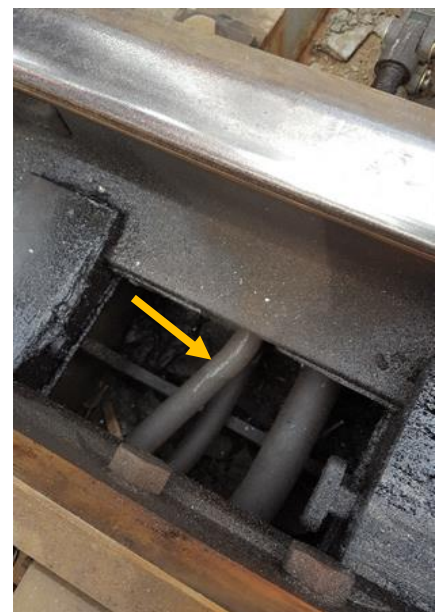
Fig. 43

It was found that there were fresh traces of mechanical friction on the upper side of the short control rod, on the washer, and the nut of the metal hollow sleeper. The length of the trace is approximately the same as is the stroke of the EPM (Fig. 43).

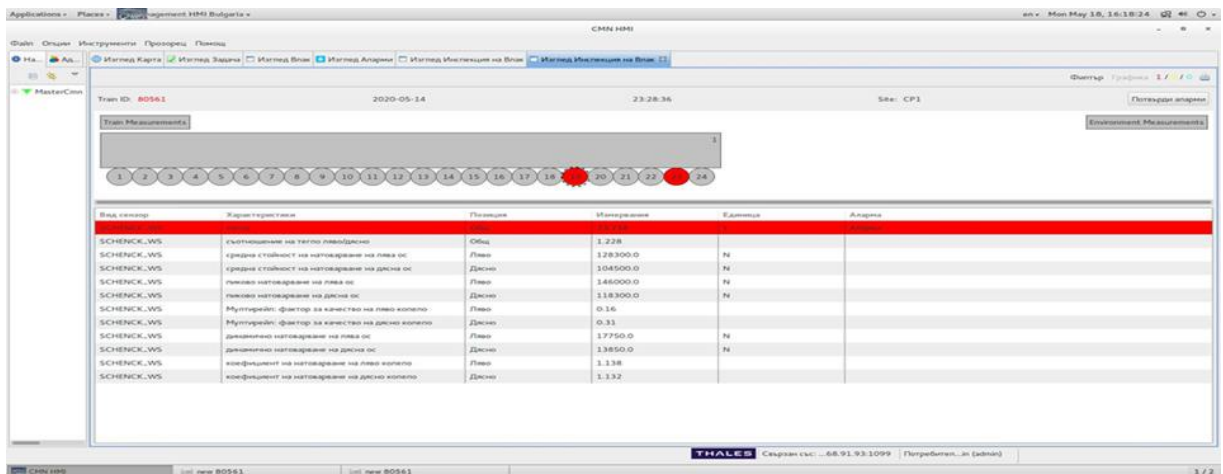
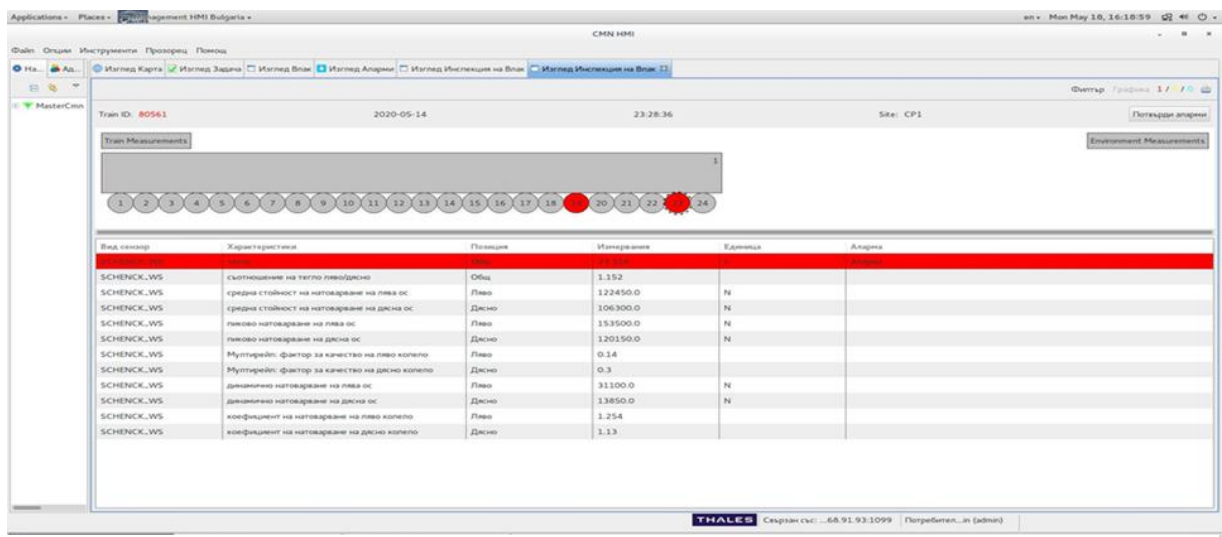
The system sets alarms on the 19th and 23rd axles, i.e. 9th and 13th axles of the wagon stock, and 1st axle of the 3rd car and the 1st axle of the 4th car, shown on Figures 47 and 48:

6. Recommendation 6 proposes NRIC to update the Instruction for work with the rolling stock control system in the section Sofia - Plovdiv, in the part minimum speed for measuring and registering the parameters of passing rolling stock, in order to accurately and completely data registering.

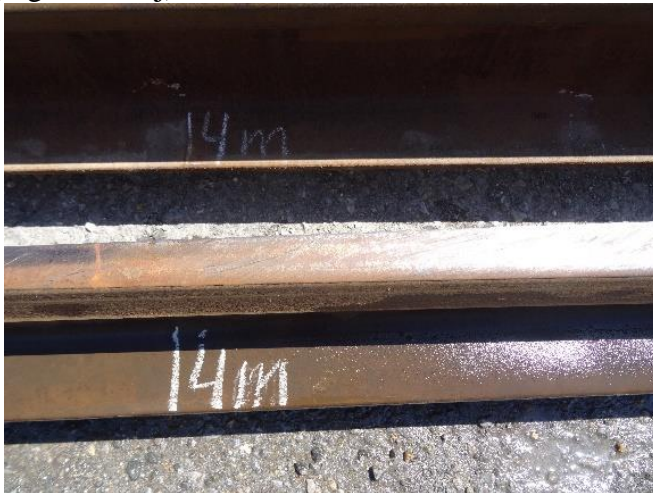
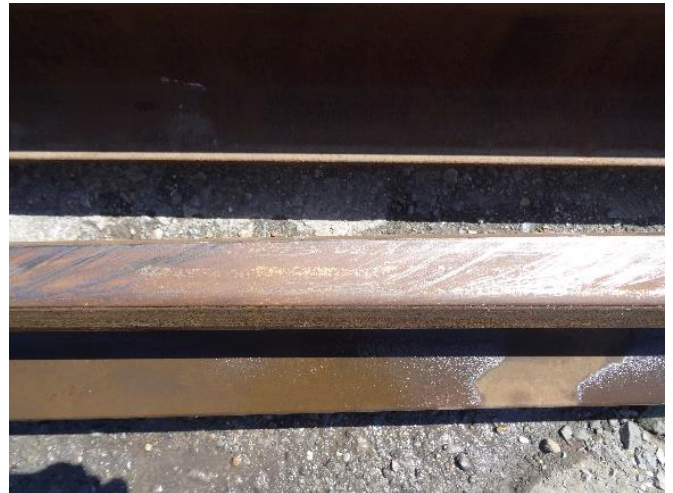
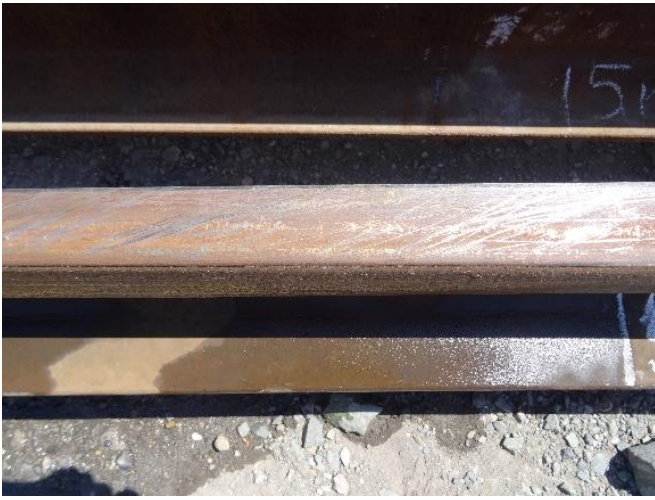
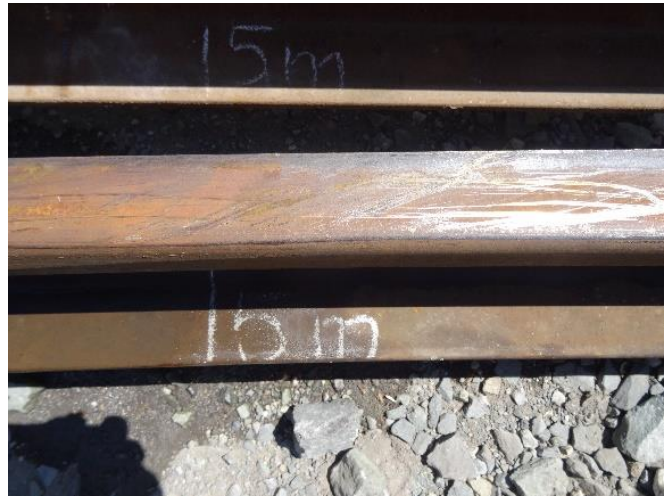
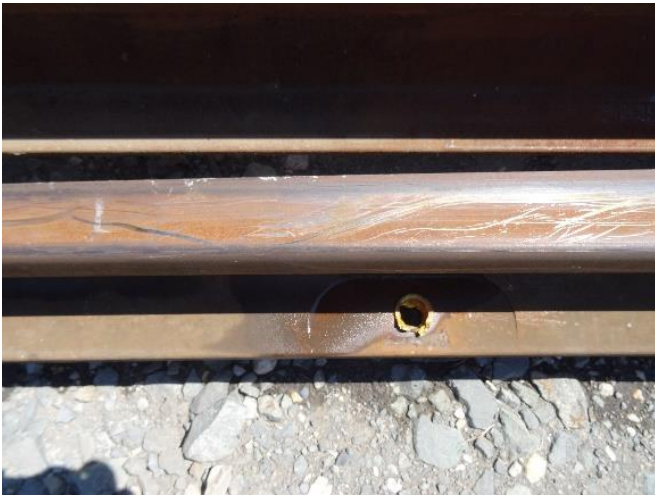
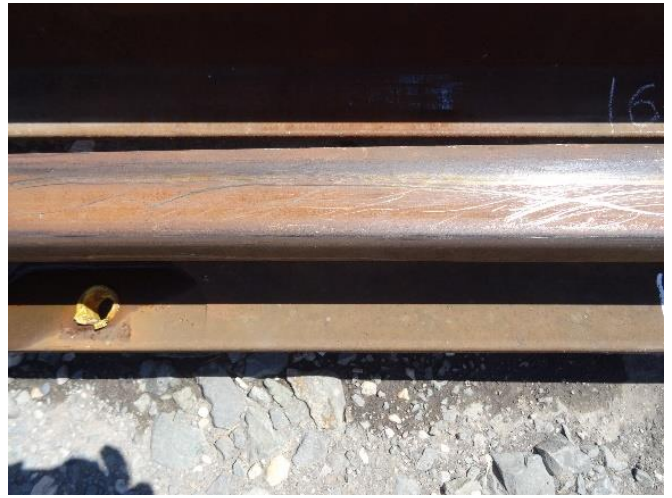
i. j.
Fig. 50. Surface of the head of the left tongue of switch № 20 between the 4th and 6th meter

Most of the traces of incision were at an angle of 60° relating to the axis of the rail (Fig. 50 a-g), but there were also such that meandered along the studied section of the rail (Fig. 50 d-g). These traces had a metallic sheen (Fig. 50 h), no corrosion products were deposited on them, which shows that they are quite fresh - obtained by moving (dragging) the tongue the day before the examination (Fig. 50 h, i, j).

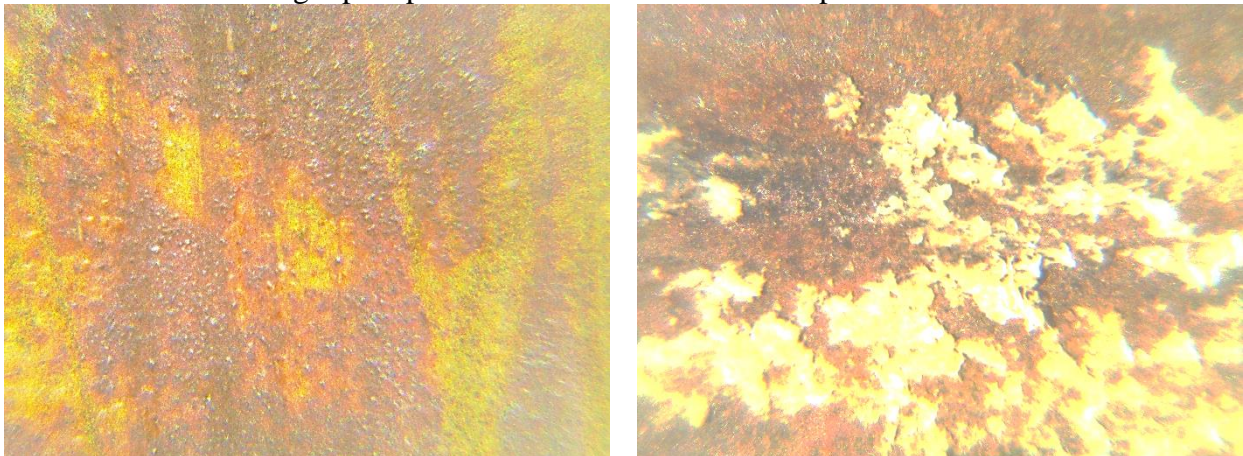
No traces of scratching or other mechanical impact on the surface of the tongue head were observed between the light precipitations and the dark corrosion products.

a. b.
Fig. 51. Microscopic image of the scratch marks before (a) and after (b) removal of the surface corrosion products.

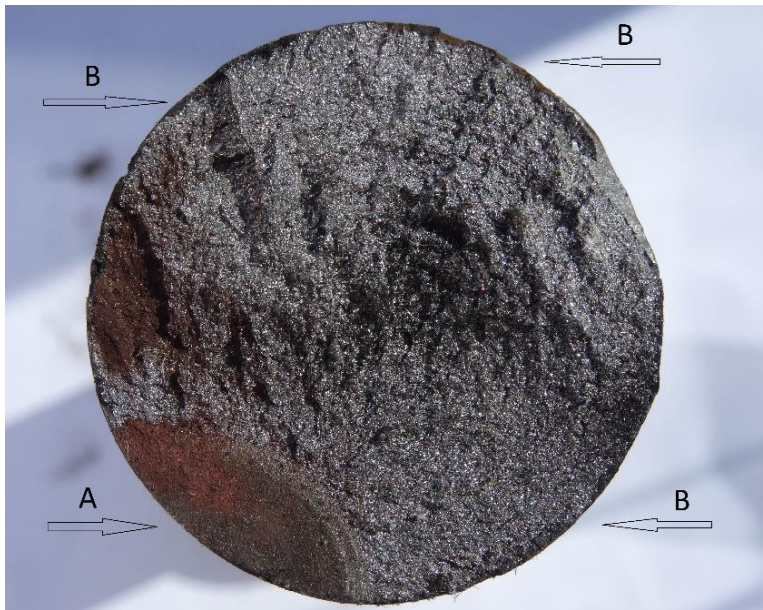
cut from the item. It is well distinguished by a large fatigue zone (A) with a relatively smooth relief (Figs. 54, 55, 56, 57) and with clearly defined fatigue grooves (Figs. 54, 55). Photos show that the spread of the fatigue grooves starts from the outer surface of the sample. Due to the development of fatigue fracture, the bearing section, resp. the bearing capacity of the hinge decreases, after which accelerated propagation of the crack under a fragile mechanism begins, zone B. In the disruption zone the relief becomes more pronounced and elongated hills are observed, oriented in the direction of crack propagation (Fig. 54). This leads to the complete destruction of the hinge. Figure 57 clearly shows the transition between the fatigue zone and the fragile fracture zone. Figure 58 illustrates the morphology of zone B, in which destruction occurs under a fragile mechanism. The percentage ratio between the fatigue fracture surface and the accelerated fracture surface is approximately 15:85. Evidence that the destruction of the hinge has begun gradually under a fatigue mechanism is the relatively smooth surface of the fracture around the initial disruption center, the presence of fatigue grooves and corrosion products on them. The most probable reason for the beginning of the destruction are defects on the surface of the hinge, which play the role of stress concentrators.

Fig. 54 General look of the disrupted hinge's surface

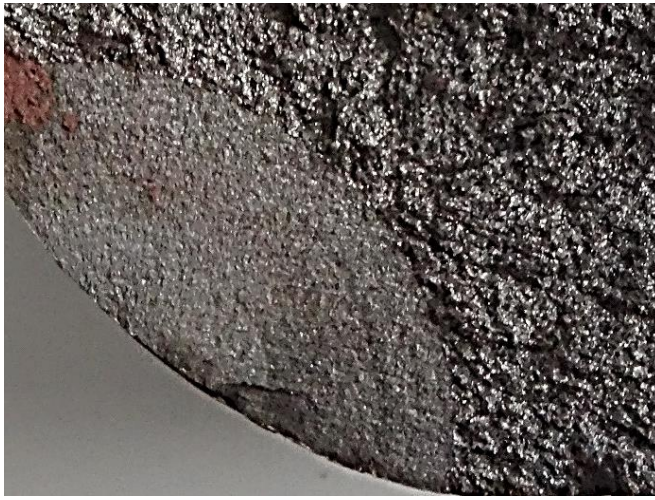
Fig.55. Fatigue grooves in zone A (OM)

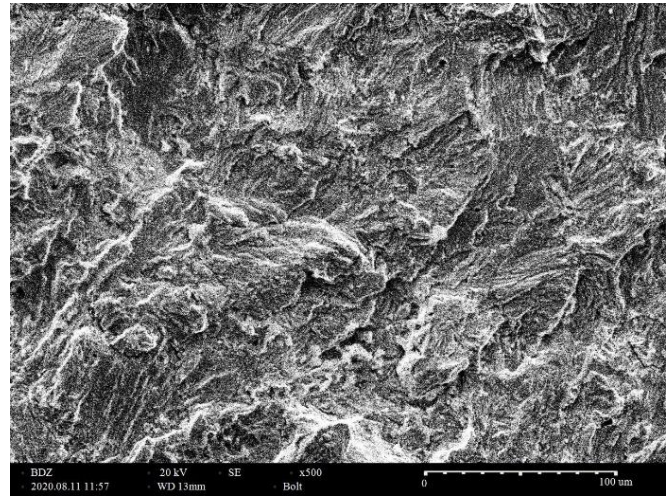
Fig. 56. Fatigue disruption zone A (CEM)

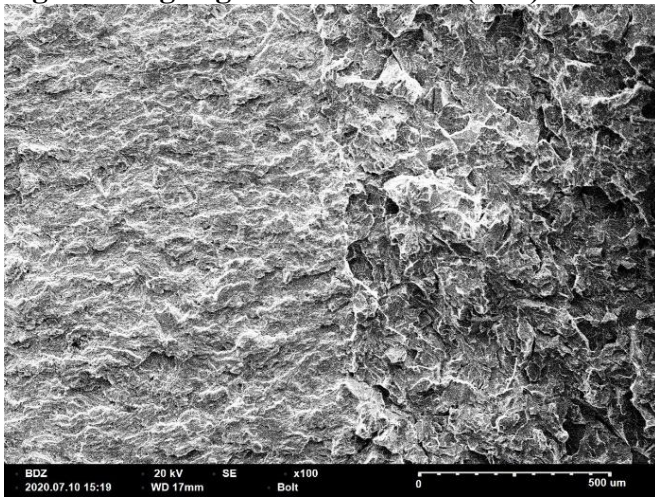
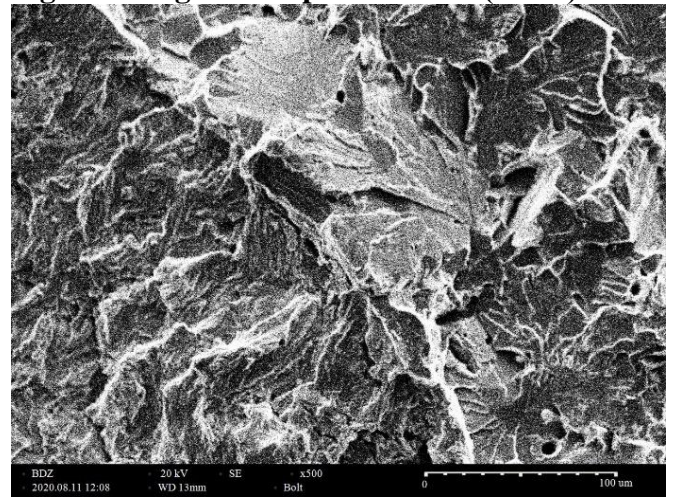
Fig. 57 Transition from a fatigue disruption zone to a fragile disruption zone(CEM)

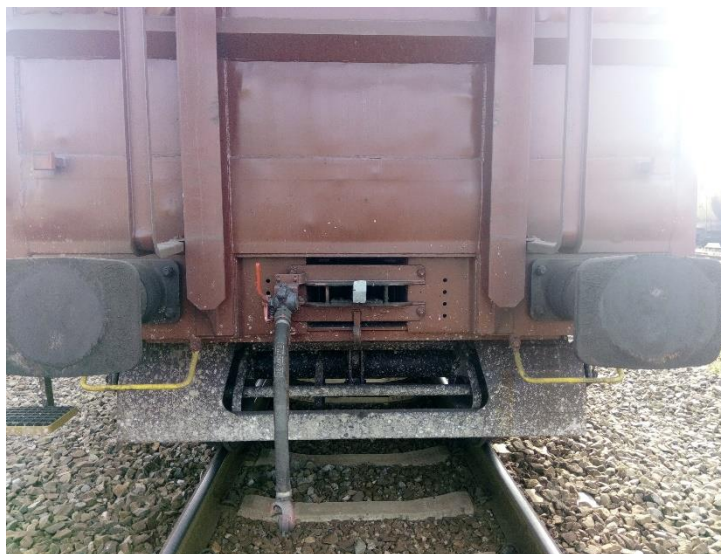
Fig. 59

The locomotive and the first five wagons of the train has passed unobstructed through switch № 20. The Investigation Commission has inspected the first five wagons and found faults only in fourth wagon of the train, № 31520806485-9 - broken traction hook (Fig. 59).

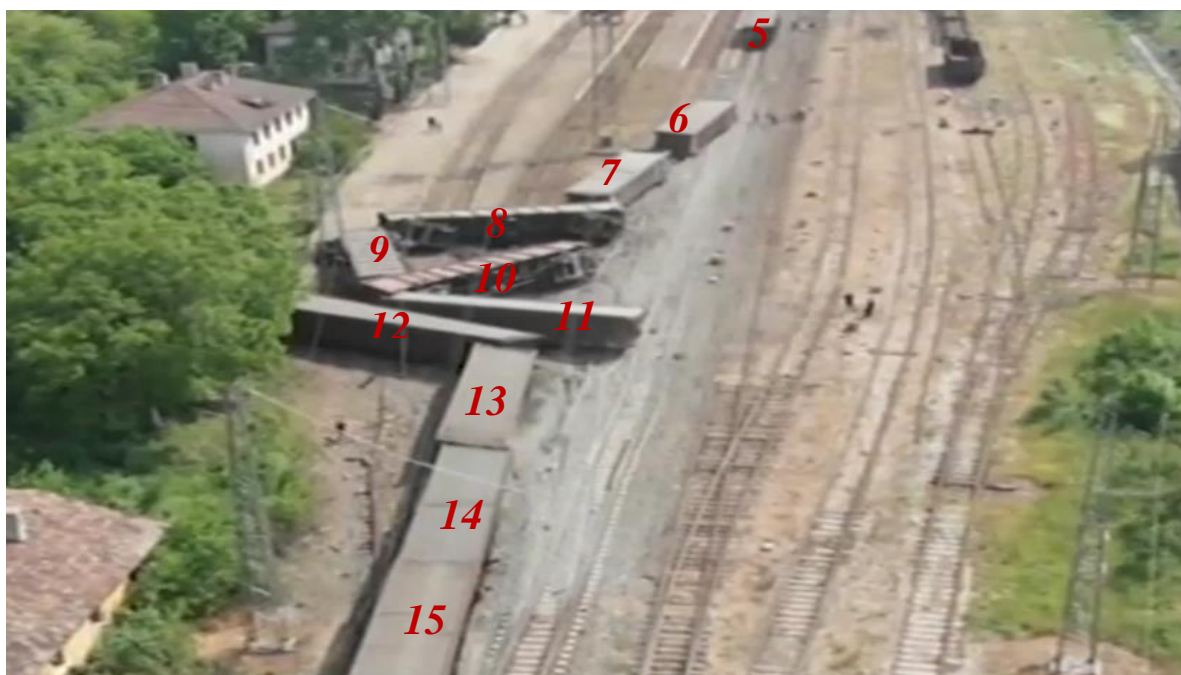
Fig. 60

1. Wagon № 33520806001-2 - sixth of the composition: the first derailed wagon (Fig. 60). Positioned between the third and fourth tracks, derailed with the four wheels, with deformed rear frontal beam and punctured transverse wall of the basket due to the impact of the seventh car, damaged bogies and wheels, loose bolt on the front screw coupling (to the fifth car), broken spring bolt on the rear earring of the first bogie of the first wheel on the left side, according to the direction of movement (Fig. 61). A brief analysis of the condition of the fracture after the disruption of the spring bolt: the structure of the fracture clearly shows the presence of the characteristic fracture zones due to fatigue of the material. A fragile disruption is observed in the base part of the section, characterizing sudden destruction by excessively high sudden loads, many times exceeding the nominal ones for the respective section (Fig. 62, pos. 3).

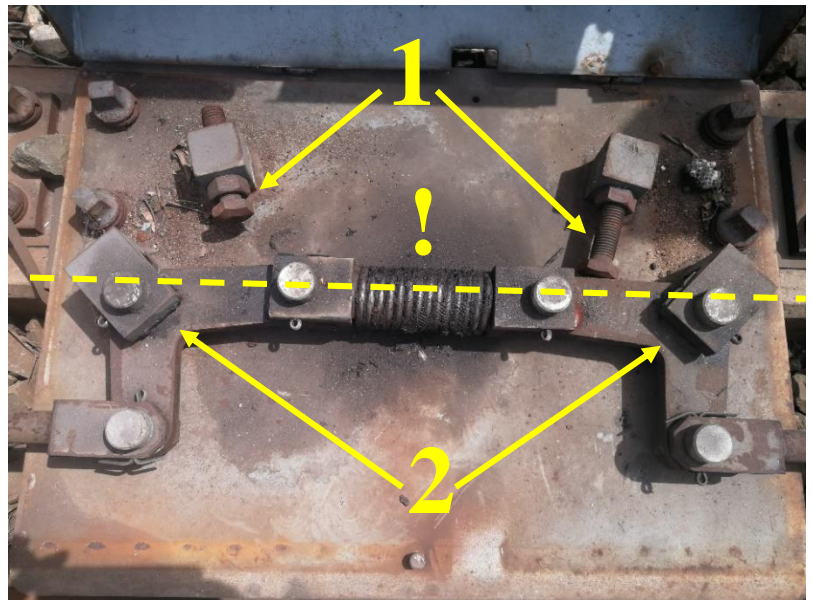
Fig. 67

- Initially, the reverse is caused by the dynamic horizontal blows of the left wheels on the tongue in the area of the spring rocker arm;
- The second stage of the reversal is caused by the two wheels of the second bogie, which cut between the left tongue and the left shoulder rail and then derail;
- The third stage of reversal is performed by the external locking device Spherolock, which has passed the equilibrium reversal point and has moved the tongues to the end (minus) position.

- The support bolts (fig. 67, pos. 1) of the rocker arms (fig. 67, pos. 2) of the spring rocker arm of switch № 20 are incorrectly calibrated, which leads to non-adherence of the left tongue to the left shoulder rail and the free right tongue remains at a distance of 40 mm from the right shoulder rail while the norm is 65 ± 3 mm. When heavier trains pass, indications for cut switch appear occasionally on the desk at the station (registered in previous cases) (Fig. 68).

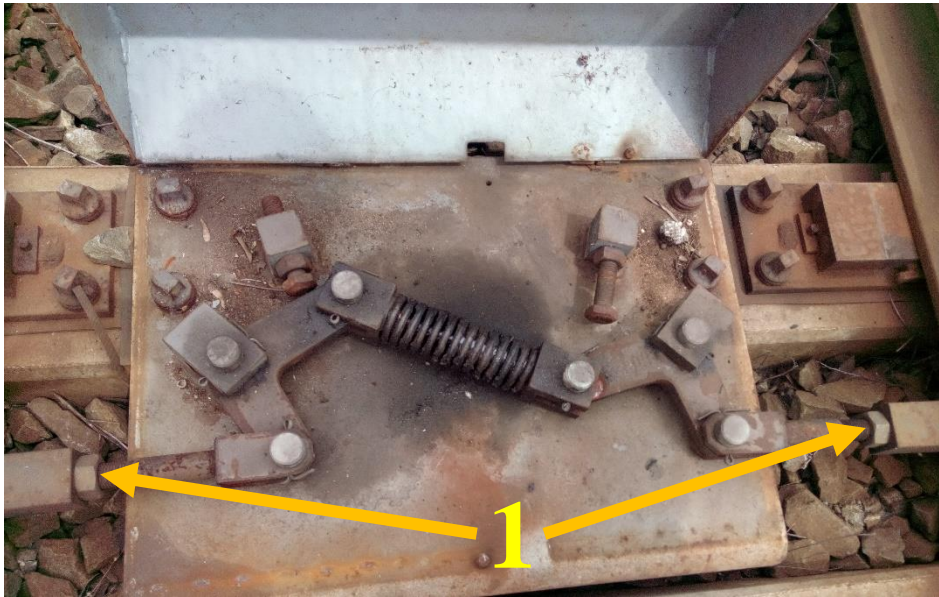
Fig. 69

- The connecting rods of the spring rocker arm are incorrectly calibrated (Fig. 69, item 1).
- During operation, the adhesion of the tongues to the shoulder rails changes and for this purpose, it is necessary to periodically be checked and calibrated. NRIC personnel are not trained to maintain this type of auxiliary reversing and spring apparatus. There are no protocols for training
