**REPUBLIC OF BULGARIA**  
**NATIONAL AIR, MARITIME AND RAILWAY ACCIDENTS**  
**INVESTIGATION BOARD**

**FINAL REPORT**

**Investigation of railway accident – derailment of locomotive № 46041 of direct freight train № 30682 while entering in Kostenets station on 15.07.2020**

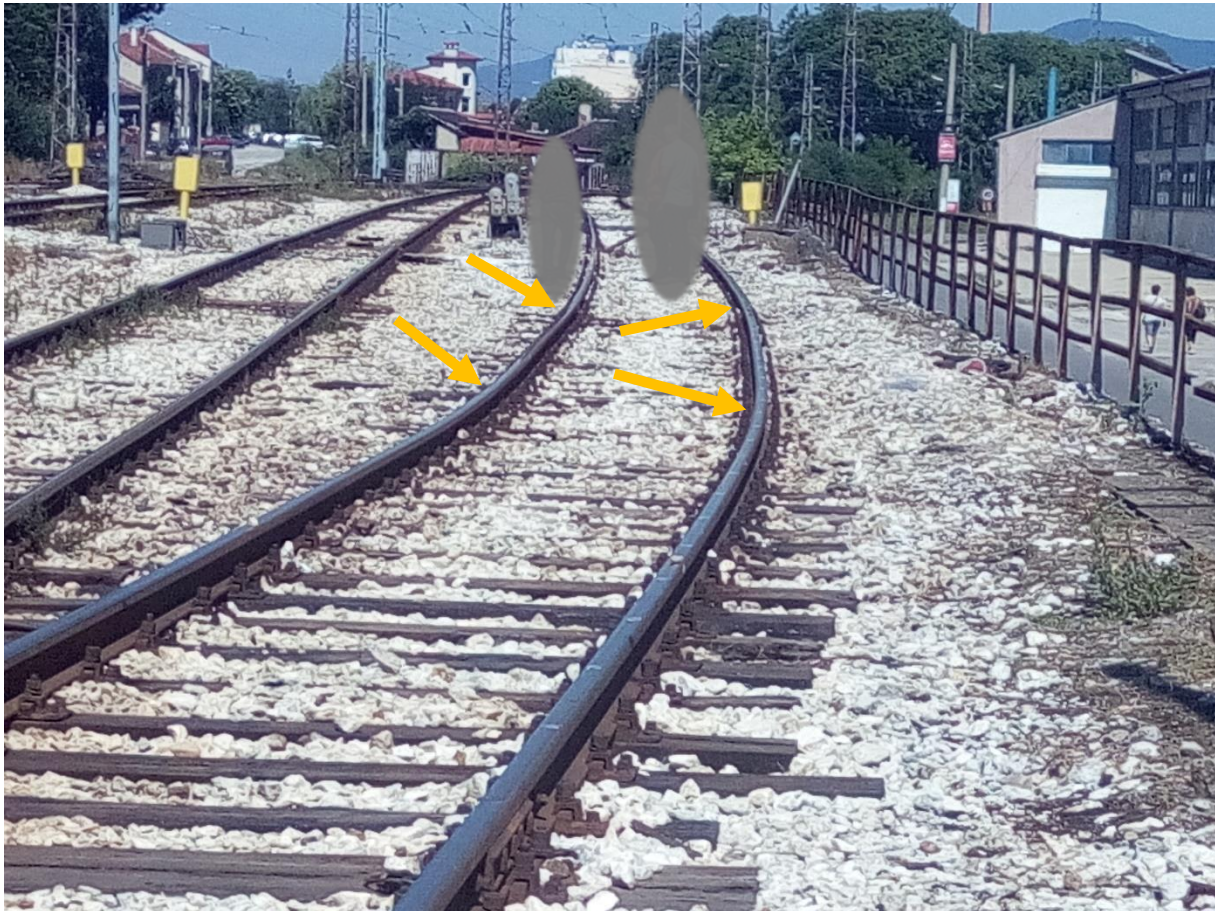
Fig. 4.5.

According to the data from the Statement of Findings of the Task Force on the condition of the rail track, it is not in norms. It is evident that the measured alignment differences in and around the derailment point further complicated the entry of the locomotive bogies, increased the steering force and the angle of attack of the driving wheel, which led to the derailment of the first and then the second in direction of the train movement wheel-sets (fig. 4.5).

• By recommendation 4 is suggested SE NRIC to arrange third track in Kostenets station as per the requirements of item 3.3.12.7 and item 3.36 for counter curves without cant without transitional curves, and without interim straight line of the Instruction for rail track and rail switches planning and maintenance.

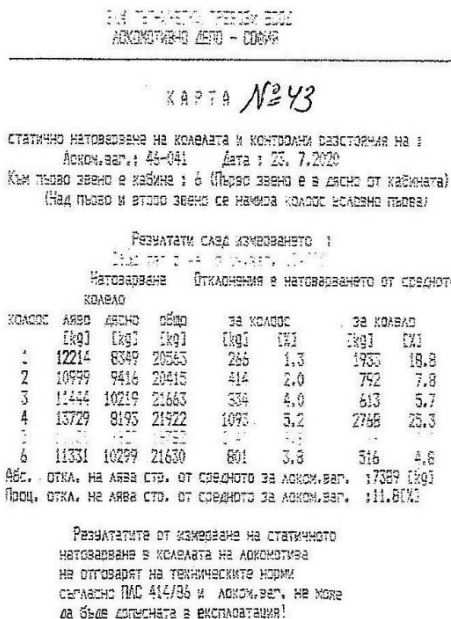
Fig. 4.11.

On 23.07.2020 again in Plovdiv locomotive depot were performed two control measurements of the static load of locomotive No 46041 under axles and again the results do not respect the technical norms (fig. 4.11 and 4.12).

The reasons for that are because of the fact that the measurements of the static load were performed on a stand for measurement of the static load of four-axle locomotives. In that case were necessary the measurement of six-axle locomotive to be performed separately per each wheel-set, which was related to the locomotive shifting for each measurement. That led to displacement of the locomotive draft-gear – position of the wheel-sets on the rail track, reallocation of the locomotive weight on the separate elements of the spring suspension that gave impact to the static load of the locomotive separate wheels.

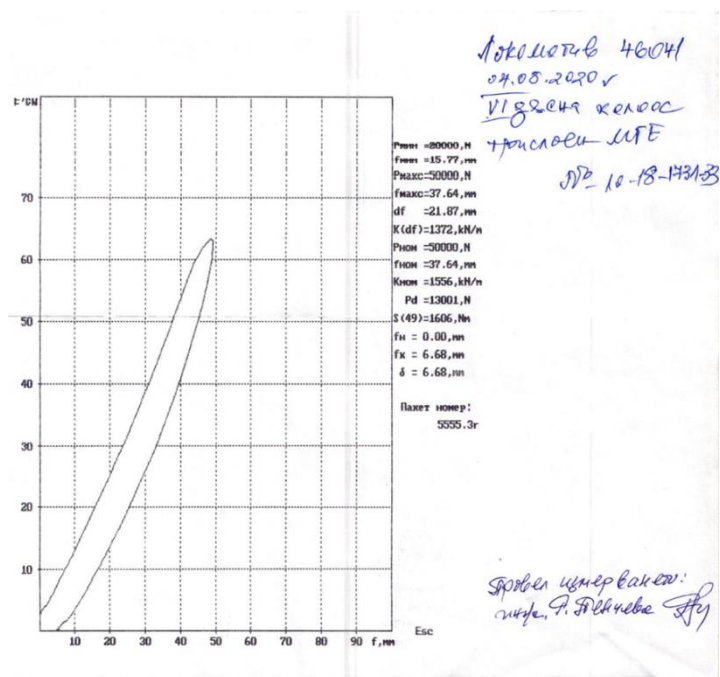
Fig. 4.15.

The results are displayed graphically on figures 4.15, 4.16 and 4.17. The parameters of the metal-rubber packs show that they are regular and are not a cause for the accident.

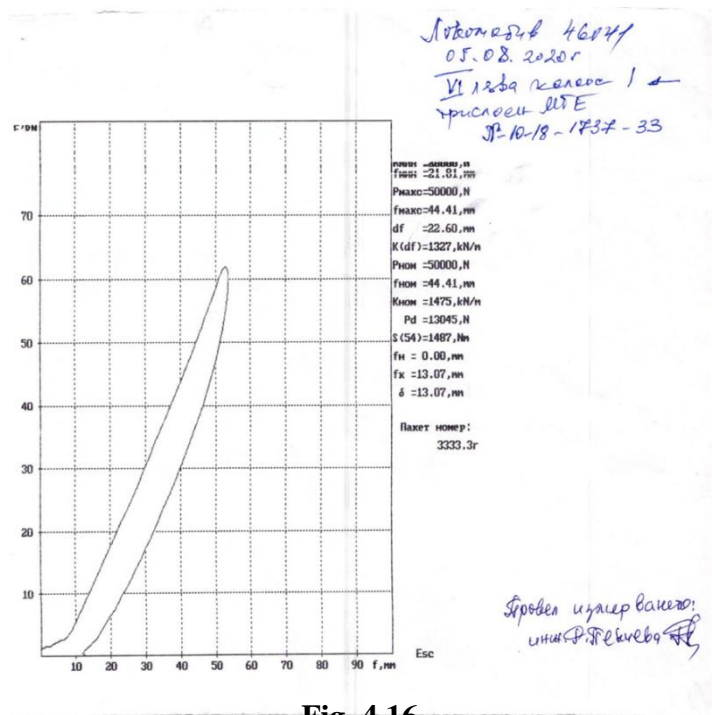
Fig. 4.16.

The main parameters of the metal-rubber pack No 10-18-1737-33 are displayed to the right from the force-deformation diagram on fig.4.16 with the registered and calculated results from the measurement:

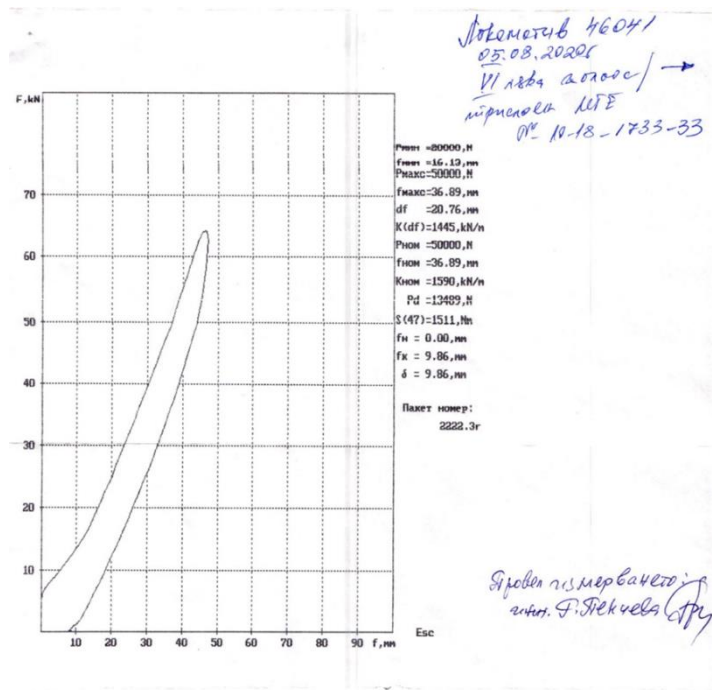
Fig. 4.17.

The main parameters of the metal-rubber pack No 10-18-1733-33 are displayed to the right from the force-deformation diagram on fig. 4.17 with the registered and calculated results from the measurement:
