FINAL REPORT

Investigation of a serious incident, occurred on July 18, 2017 at Burgas Airport, Bulgaria, by AIRBUS A320-232, registration marks SX-ORG, operated by ORANGE2FLY

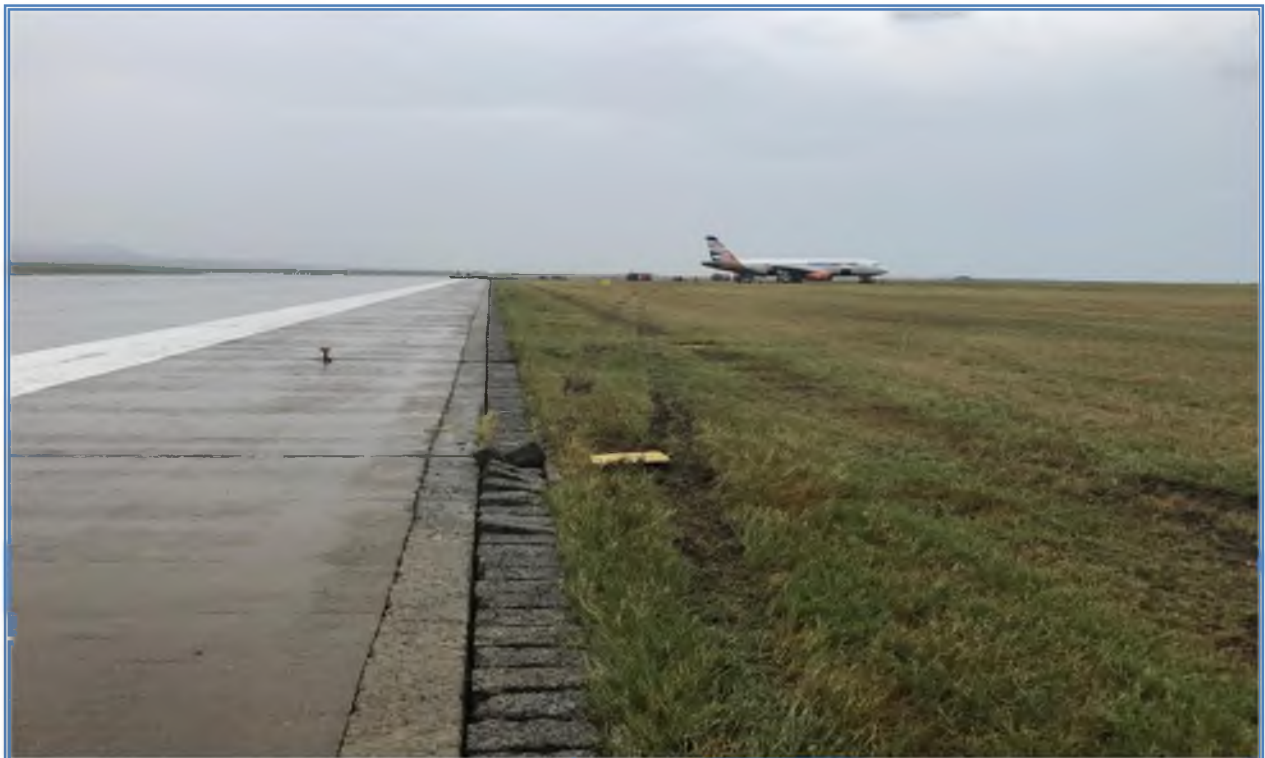
Fig .2

- Broken lamp of RWY edge lights system, fig. 2 of Appendix 1;
- A cover of the RWY drainage system is damaged, fig. 2 of Appendix 1;
- An aerodrome indicative sign is damaged, Fig. 2 of Appendix 1.

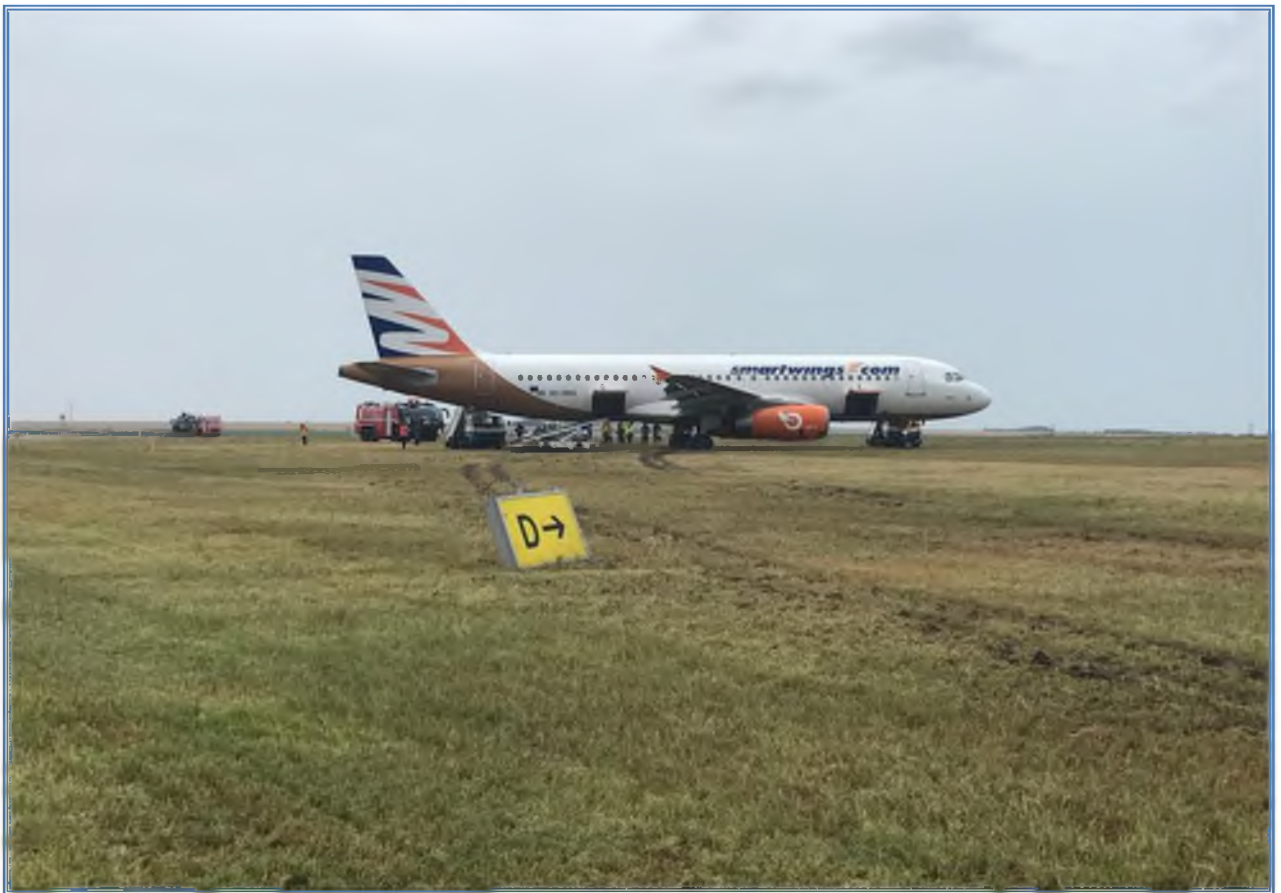
Fig. 3

- A slot of 800 mm in length and 20 mm in outboard Fan Cowl of engine No1 (Figure 4 of Appendix 1) caused by a collision with taxiway indicative sign when the aircraft exit the RWY (Figure 3 of Appendix 1);
- R/H MLG Downlock actuator flexible hoses external leak (Figure 6 of Appendix 1);
- Traces of leaked hydraulic fluid from Green hydraulics in the right main landing gear bay (Figure 6 of Appendix 1);
- Cut tyre protector from wheel № 4 of the main landing gear while passing through a side-marker lamp from RWY lights system (Figure 7 of Appendix 1);
- Contamination with grass and mud on the landing gear, wings and tail due to the movement of the aircraft on the ground outside the runway, Fig. 8 of Appendix 1.
