FINAL REPORT

the Commission for Investigation concerning the serious incident (Airprox) involving the Boeing B737-800 aircraft, registration marks OK-TVM, operated by Travel Service a. s., and the Airbus A321-200 aircraft, registration marks G-TCDG, operated by of Thomas Cook Airlines Ltd., on 23 July 2019 in the controlled air space of the Republic of Bulgaria.

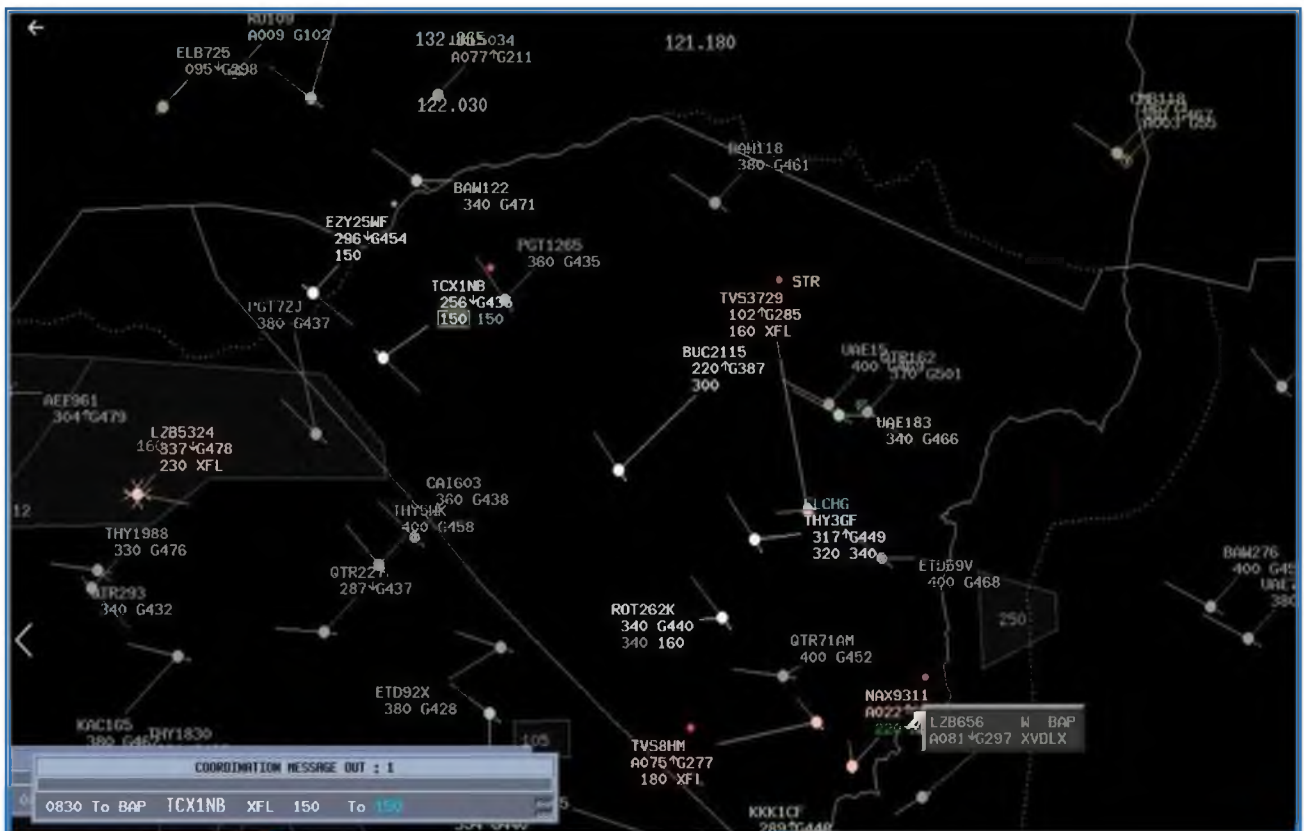
Fig.2

At 08:31:02, Automated ATM System SATCAS generated warning for MTCDD between A/C TCX1NB and A/C TVS3729. The potential conflict was displayed on the Controller Working Position of family sector VBL. The distance between the two aircraft is 66 NM (Fig.2).

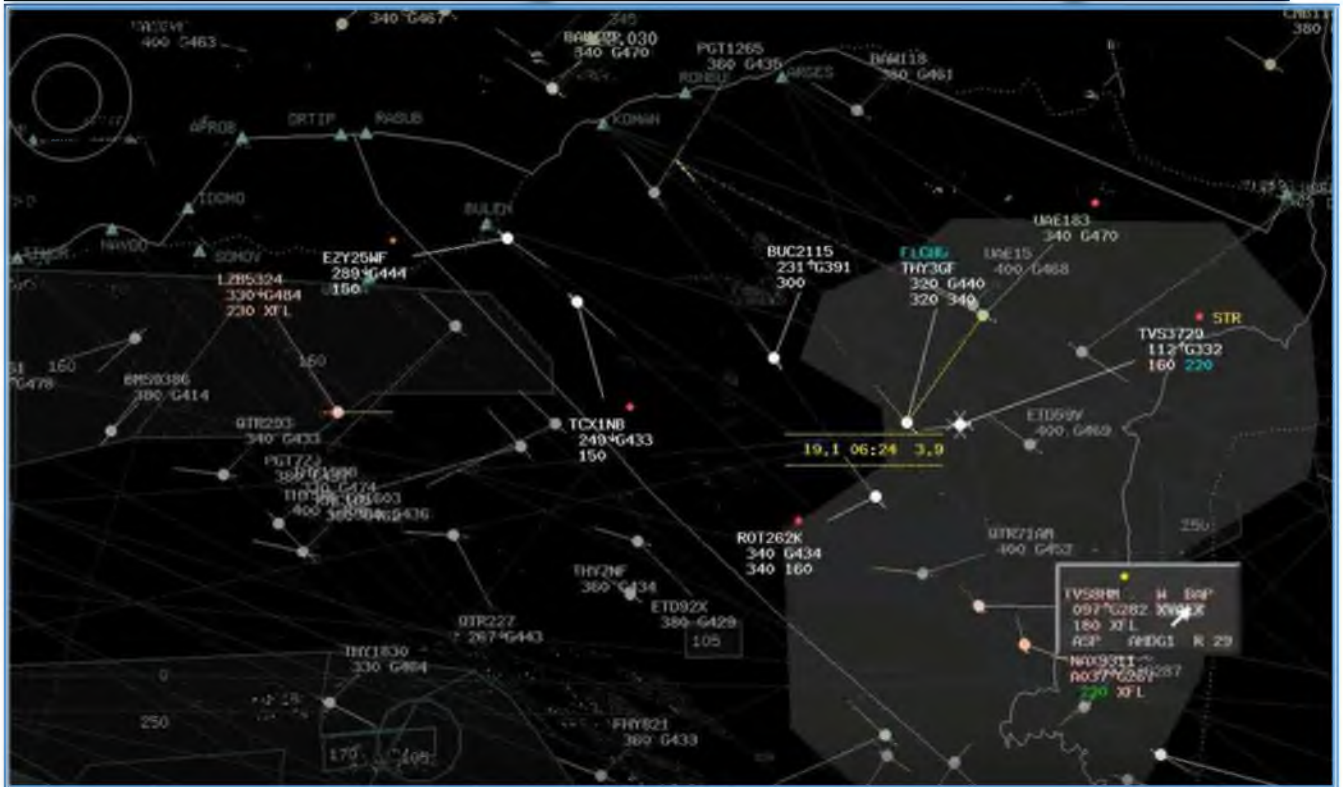
Fig.3

At moment, EXE ATCO and PLN ATCO did not notice the warning for MTCDD between A/C TCX1NB and A/C TVS3729. The distance between the two aircraft is 59 NM (Fig.3).

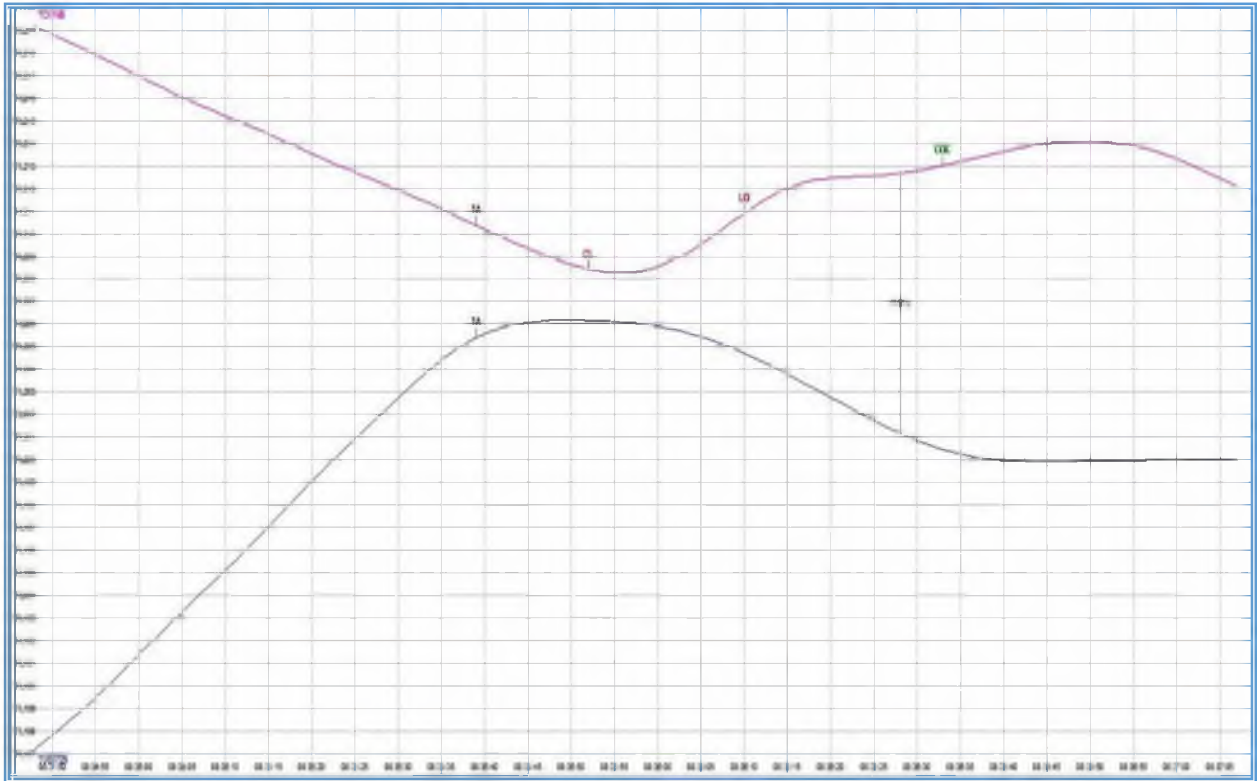
Fig.4

At 08:35:39 based on the simulation conducted by InCAS v4.2.3 (Interactive Collision Avoidance Simulator), both aircraft received Traffic Advisory.

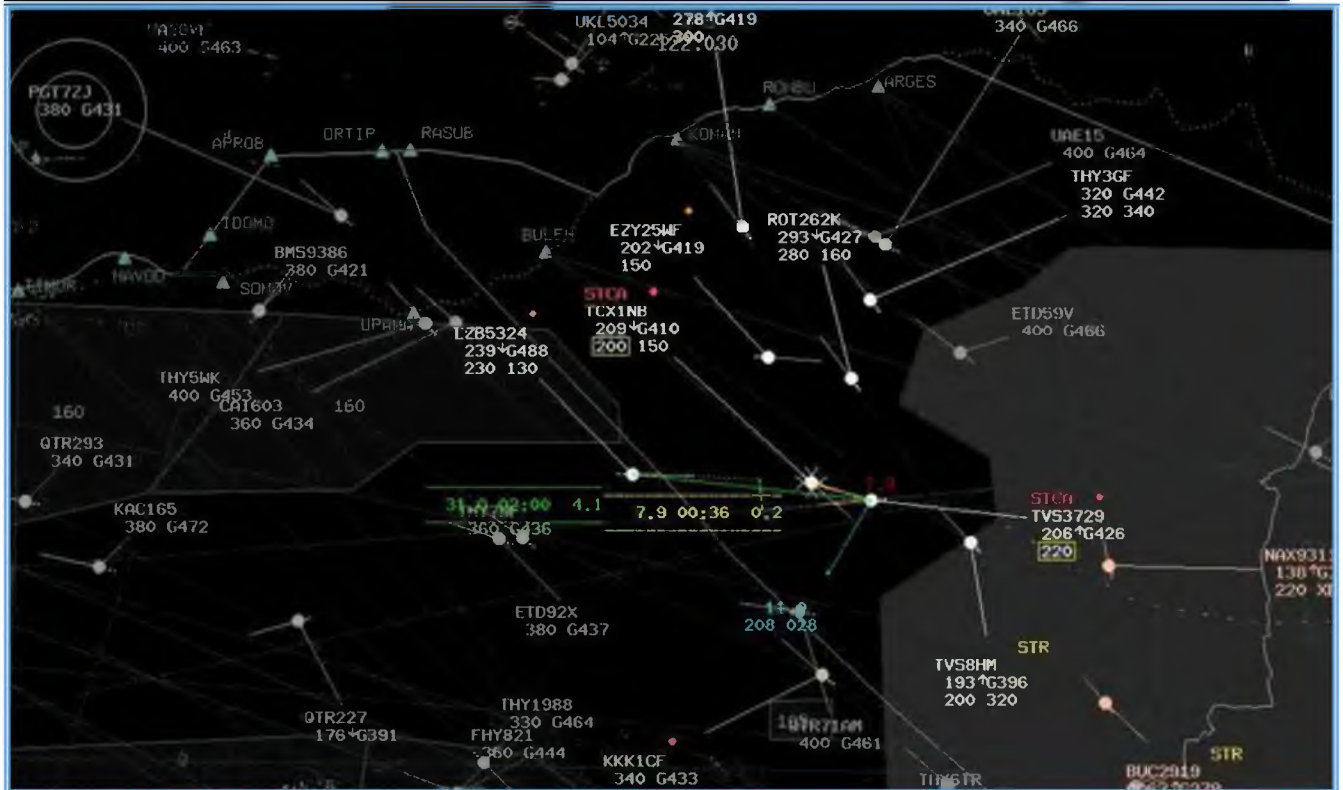
Fig.5

At 08:35:50, Automated ATM System SATCAS generated visual indication in bright red colour with sound alarm for STCA between A/C TCX1NB and A/C TVS3729, which is displayed at both the working positions of VBL sector. At the present moment TCX1NB crossing FL209 in a descent and TVS3729 crossing FL206 in a climb. The distance between the two aircraft is 7,9 NM (fig 5)

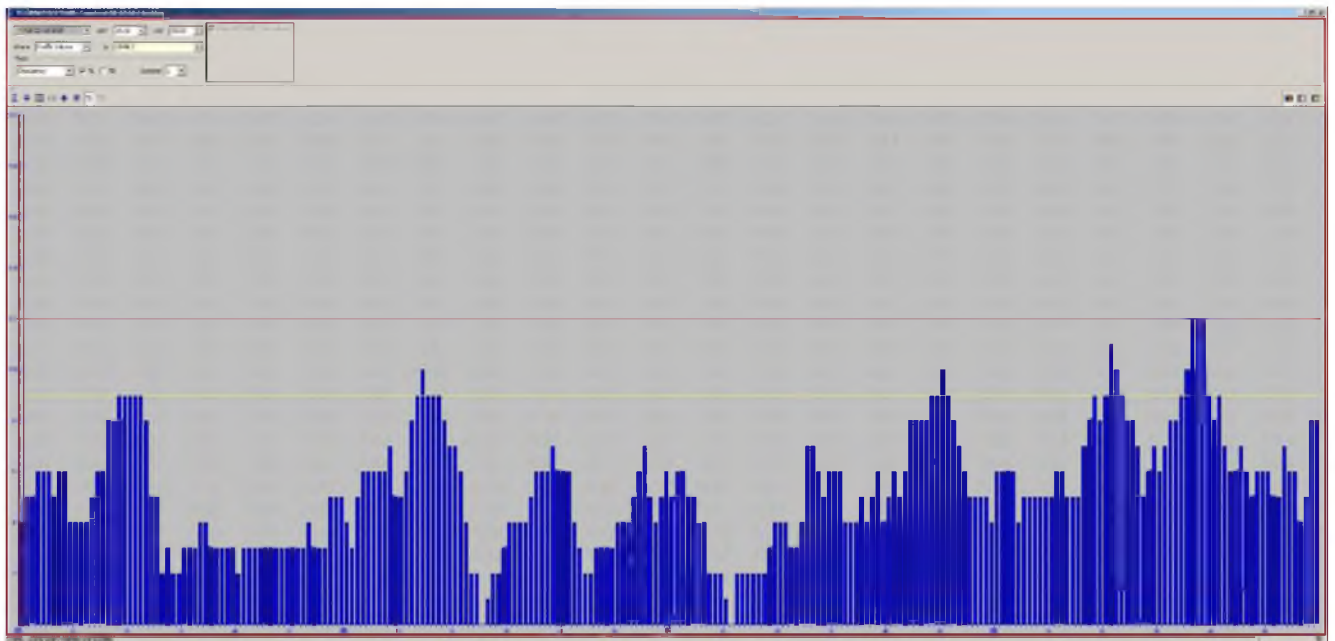
The Supervisor changes the sector configuration for Sofia Control Unit, FS Varna, and FS Sofia in order to avoid exceeding of the declared sectors’ values. Fig.8 shows the traffic data for sector LBNL3 (VBL).

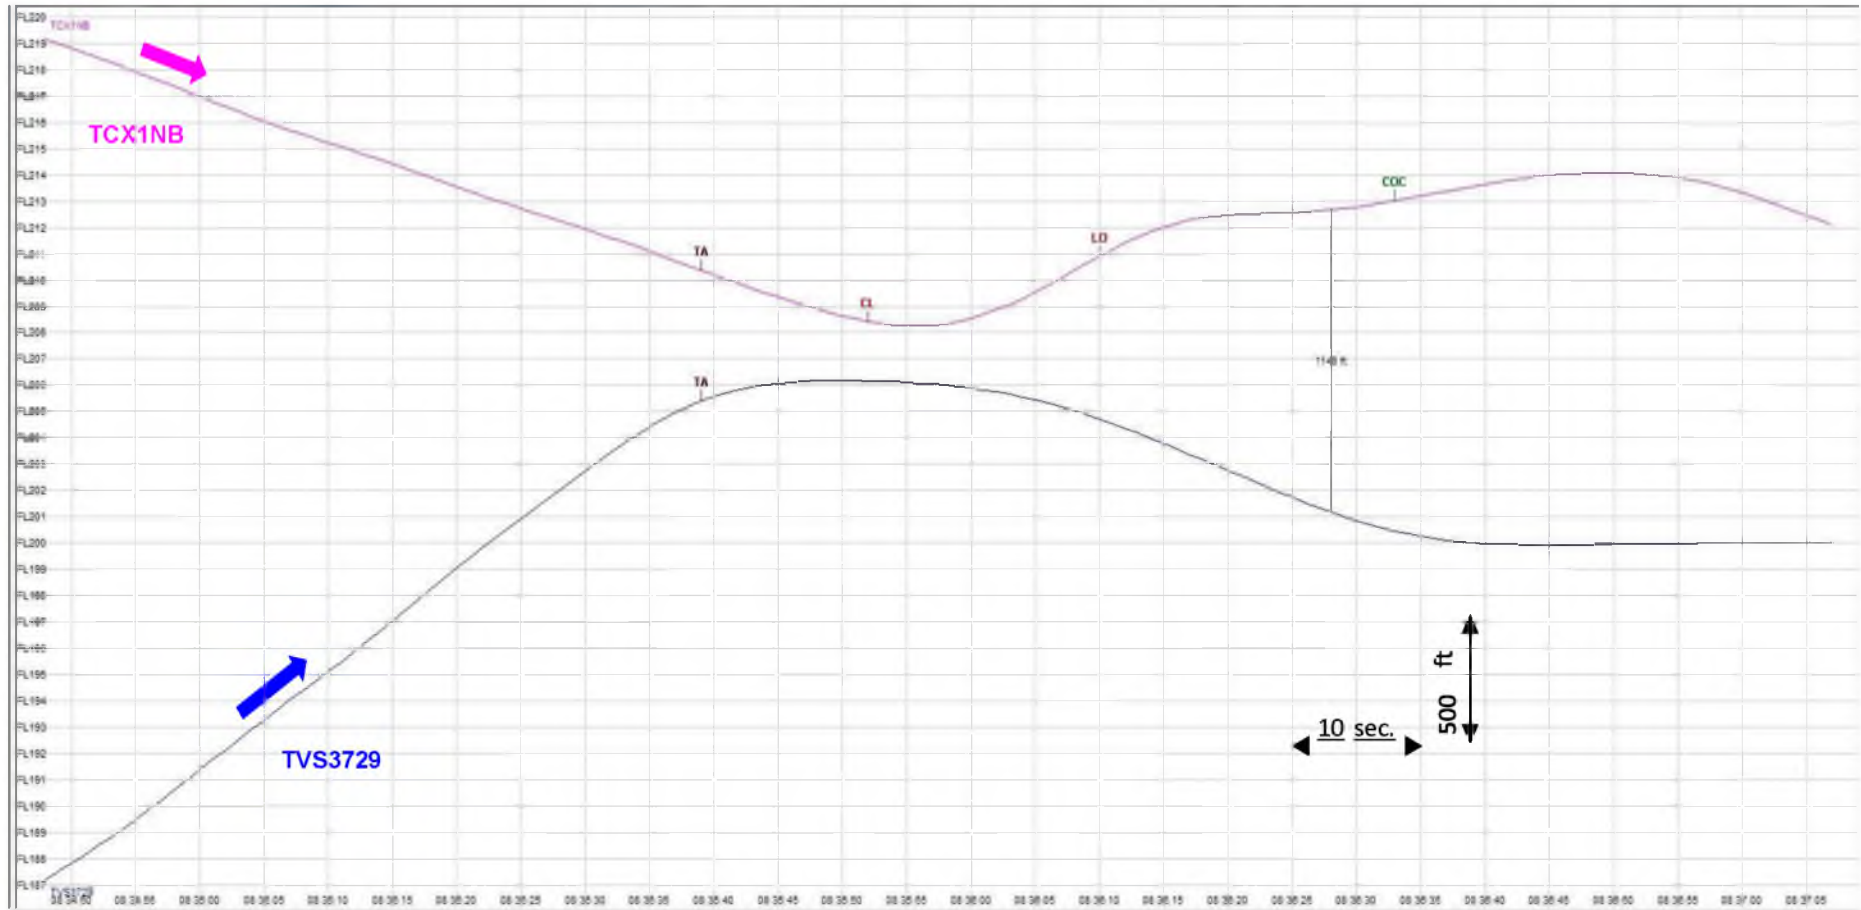
InCAS vertical trajectories

Timing of alerts per InCAS simulation.

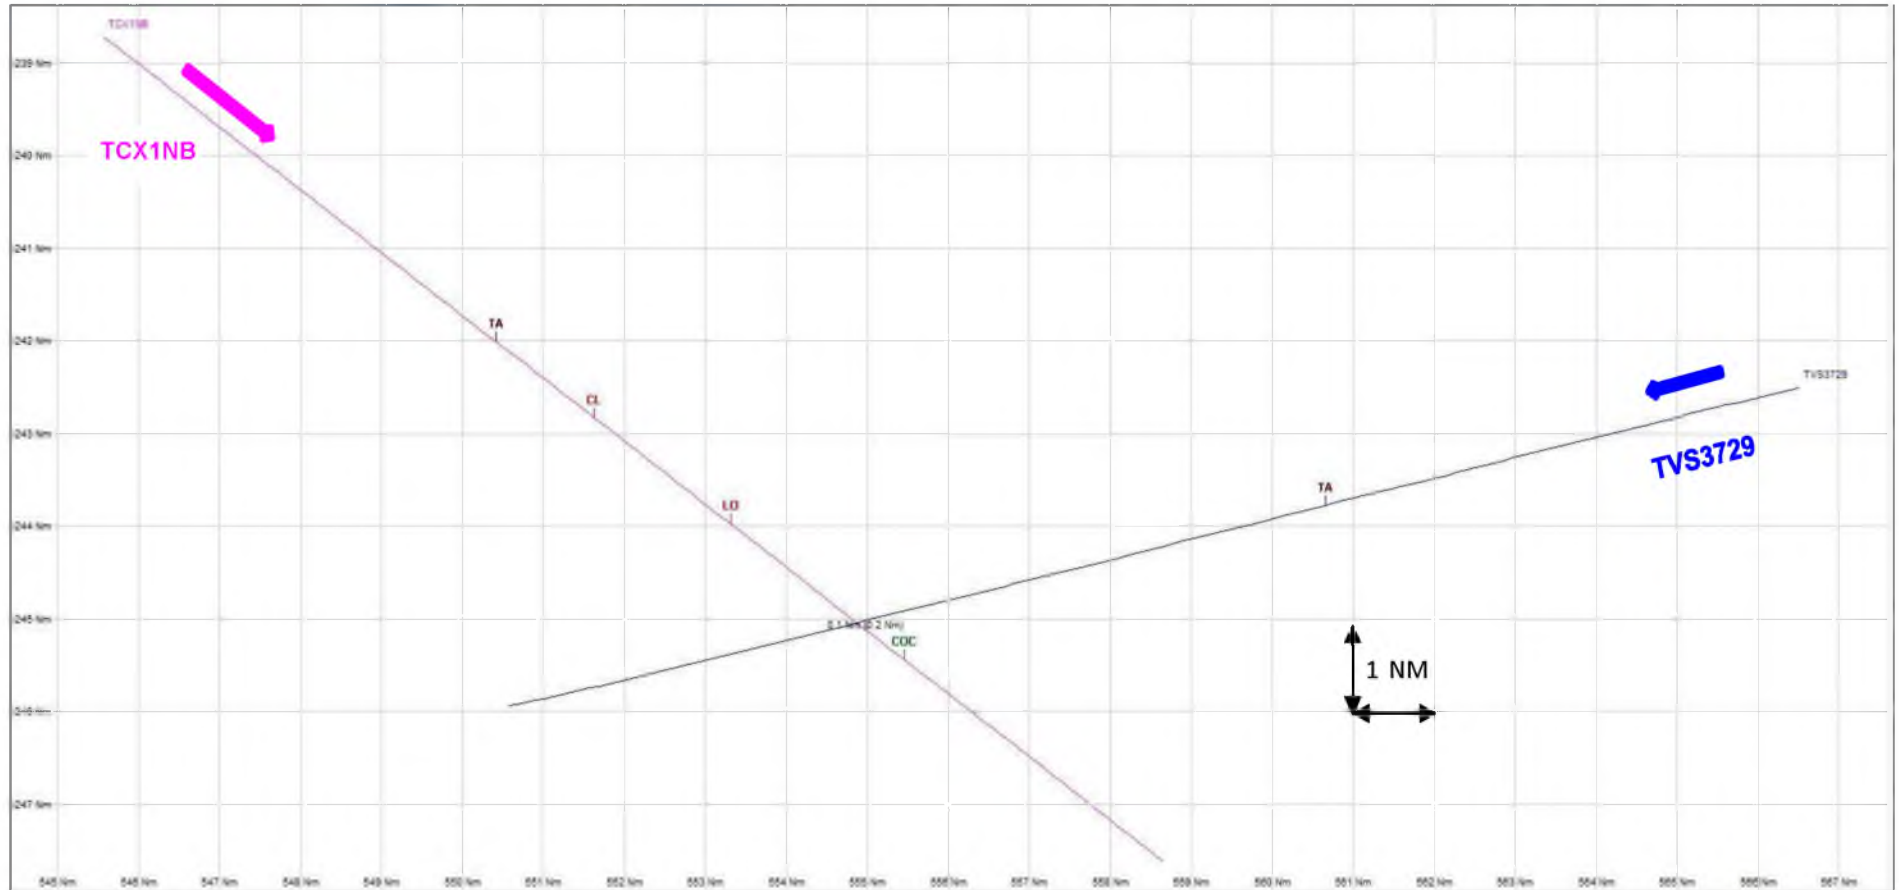
InCAS horizontal trajectories

Timing of alerts per InCAS simulation.
