**Aircraft, Maritime and Railway Accident Investigation Directorate
Maritime Accident Investigation Unit**

FINAL REPORT

**Investigation of a serious marine accident –
FIRE IN THE SPACE BETWEEN QUAY AND SHIP BOARD AND
EXPLOSION IN BALLAST TANK OF M/T "VF TANKER 7" IN THE
PORT OF SPECIAL PURPOSE "TEREM - KRZ FLOTSKI ARSENAL -
VARNA"**

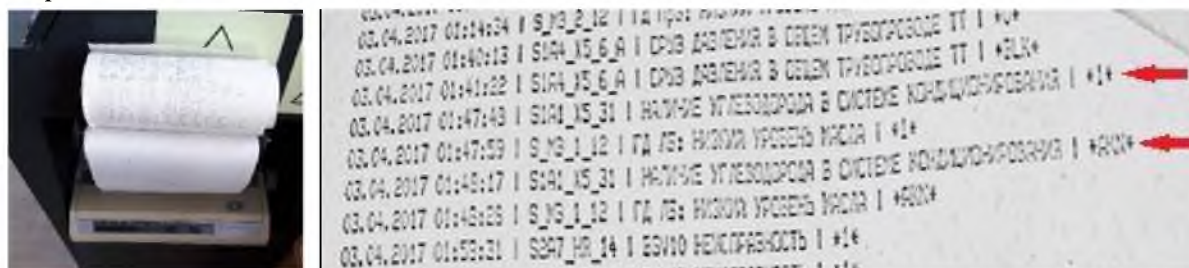
Fig. 5

On 03 April 2017, at 0147 and at 0148, the ship's *Integrated control, command and signaling system* signaled the presence of hydrocarbons in the air conditioning system (Fig. 5), as a result of which the ship's alarm has been triggered. The ship's duty service has not responded.

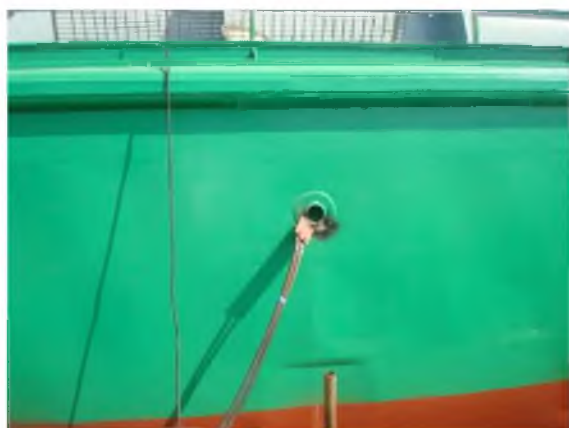
Fig. 6

At 1028 the welders positioned on the quay try to weld at the s/b outside of the ship, in the area of the midship, a metal plate (fig. 6) for which the zero conductor of the welding apparatus to be connected to the hull. When welding the plate to the hull, sparks and slag began to fall into the water between the tanker and the warf. The falling sparks/slag in the water ignited the mixture of air and vapors from the spillage between the ship and the warf containing a significant quantity of petroleum products.

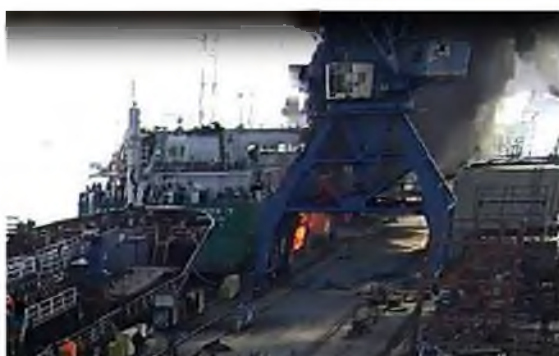
Fig. 7

The fire is strong, the flames for few seconds spread along the entire starboard of the ship, as the highest reaching to 4 m were in the area of the superstructure (fig. 7). Workers and crew moved away at a safe distance. A fire alarm was triggered on the ship, the shipyard fire brigade located in the immediate vicinity of the ship arrived and began extinguishing the fire.

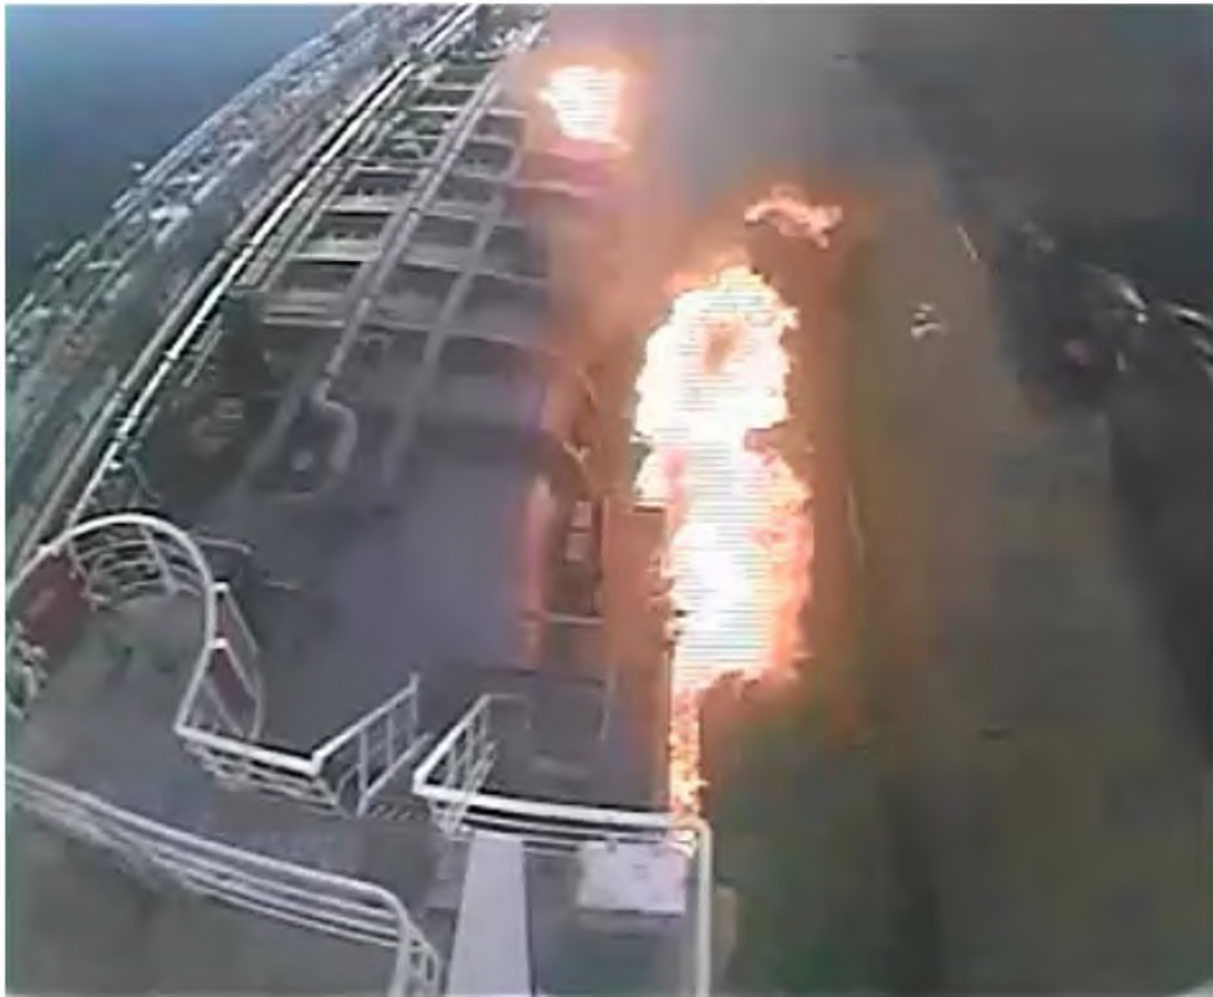
Fig. 8

One minute after the fire occurred, the flames reached the open man hole of s/b ballast tank № 7 and ignited the inside of the oil products vapors (Fig. 8).

There was a strong explosion in the ballast tank, the ship was pushed at a distance of 5-6 meters from the wharf, but the mooring ropes hold her and take her back. The fire was burning 10 minutes and extinguished both because of the flammable substance was over and the actions of the crew and the shipyard fire brigade. The crew, the shipyard fire brigade, the arrived fire cars and the shipyard cutter continued to pour the boards for their cooling. A floating boom was set around the ship. A coercive ventilation of the ballast tank was organized.

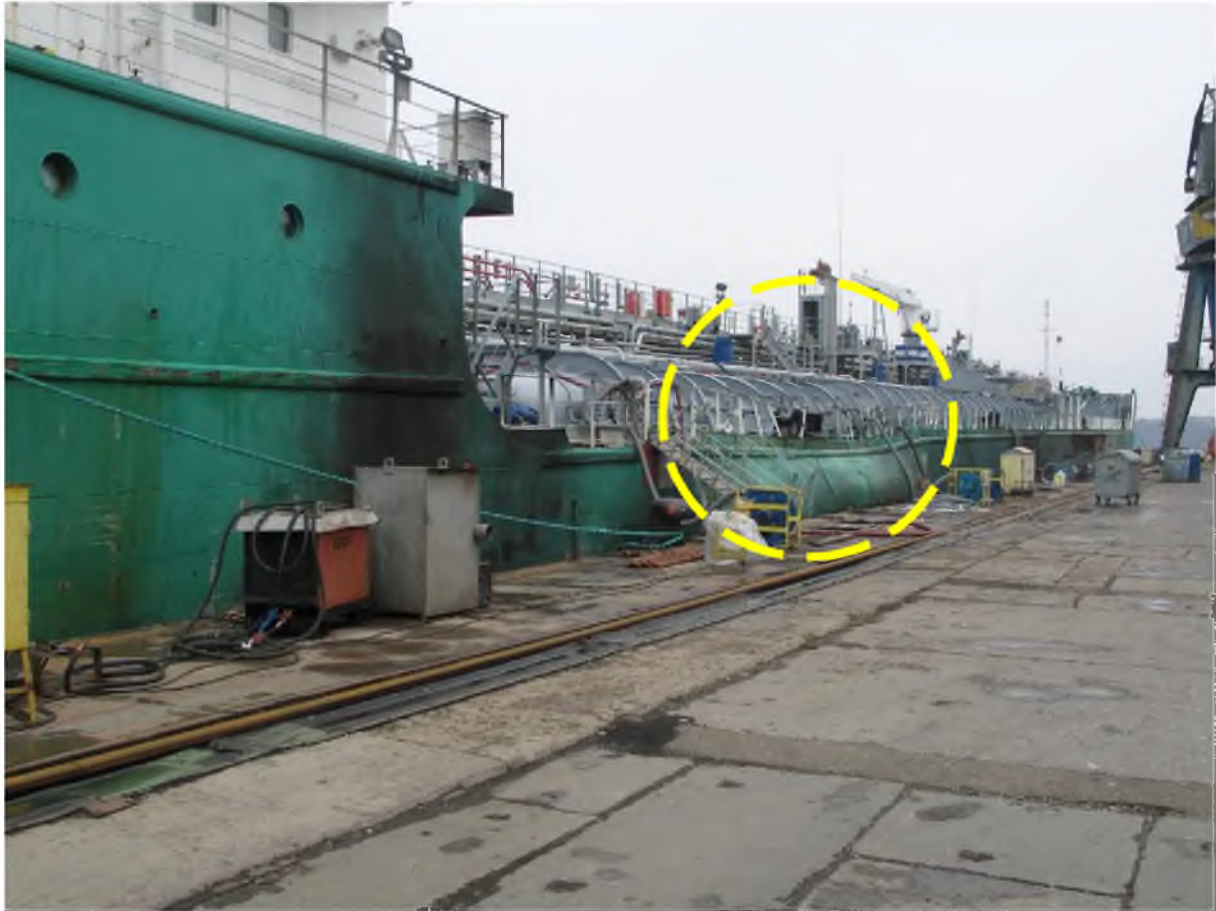
Fig. 9

As a result of the explosion, the wall of s/b ballast tank № 7 was strongly deformed and bulged in the direction to its outside (Fig. 9). The internal partition between the ballast tank and cargo tank № 6 was deformed and bent. In the area of s/b ballast tank № 7 deformations were caused to the outer hull, the open deck, transverse and longitudinal frames. In s/b ballast tank № 7 and cargo tank № 6 begins to enter overboard water. The ship gets a list to starboard side. An underwater diving inspection found 3 holes under the waterline, on which patches were placed. Pumping of entering water and straightening the list were organized.

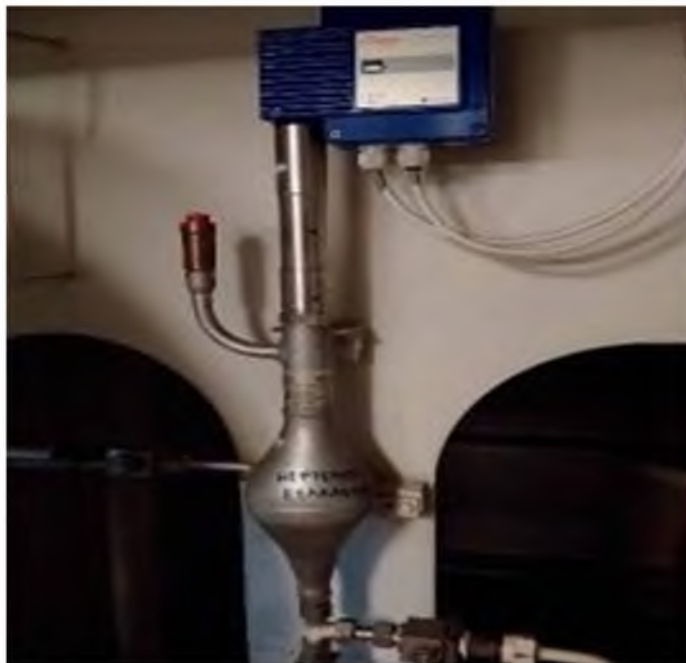
Fig. 10

After the accident, the ship was inspected by representatives of the Directorate "Maritime Administration" - Varna. The inspectors have found the presence of waste on board the ship - a result of shipping activity and load residues that have not been declared at the *National Electronic Documentation Center* of the Maritime Transport at the entrance control of the ship. When checking the performance of the oil detector system "*Oil Detector & Alarm*" ORGS 11-2 (fig. 10), it is found that the crew encounters difficulties in its launching and adjustment, which raises doubts in its regular usage.

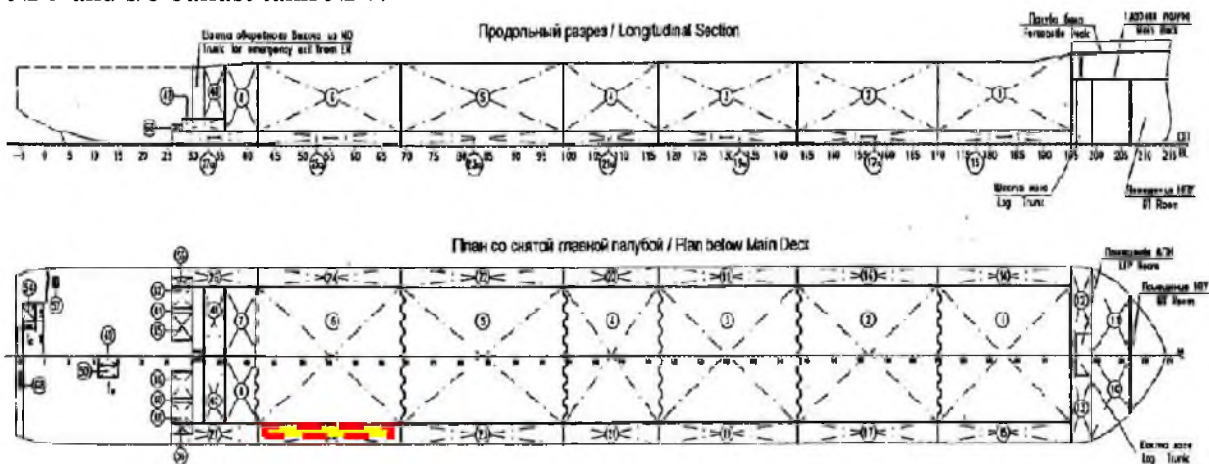
Fig. 12 A scheme of ballast tanks

1. Both ballast tanks do not physically contact a slop tank (Fig. 12).

2. Although a physical contact through the inner casing of both s/b ballast tanks № 6 and № 7 respectively with cargo tanks № 5 and № 6 is possible, even after the explosion in s/b ballast-tank № 7 there are no broken welds, cracks or openings through which a connection between s/b ballast tank № 7 and cargo tank № 6 and, hence, overflowing cargo from the cargo in the ballast tank could happen. The state of s/b ballast tanks № 6, its construction and welds also exclude the possibility of a direct connection through the partitions both with cargo tank № 5 and s/b ballast tank № 7.
