**Aircraft, Maritime and Railway Accident Investigation Directorate  
Maritime Accident Investigation Unit**

**FINAL REPORT**

**Investigation of very serious marine casualty –**

**FIRE IN ENGINE ROOM AND DEATH OF A CREW MEMBER OF  
*M/V „KARADENIZ 5“ ON 14.08.2018***

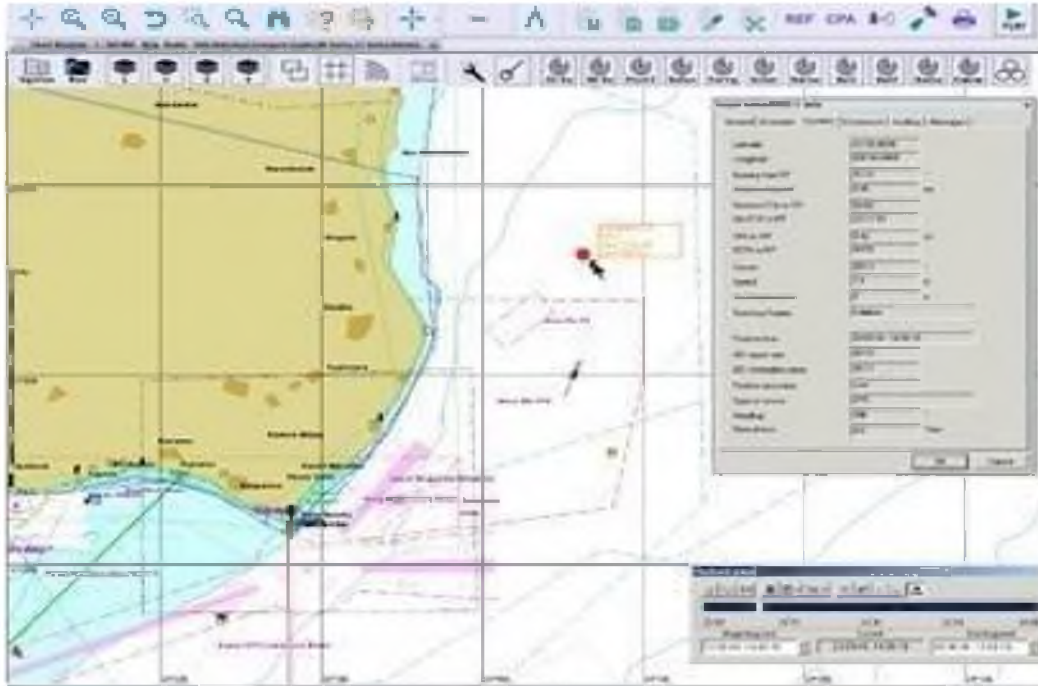
(Fig. 5)

On 14.08.2018, at about 1730 *m/v "KARADENIZ 5"* sailed from Constanta, Romania, unladen and ballasted, to the island of Marmara. During the voyage, the main engine was operating, with the electrical power supply being produced by the shaft generator connected to the engine. At 2000, the chief engineer had gone on watch in the ER. By 2100 *m/v "KARADENIZ 5"* was located abeam the village of Krapets, at about 11 nm from the coast (**Fig. 5**). The weather in the region was clear and good visibility, waves 1-2 BN and low wind from the northeast.
