**AIR, MARITIME AND RAILWAY ACCIDENTS INVESTIGATION
NATIONAL BOARD**

FINAL REPORT

Investigation of a serious railway accident - derailment of a freight train № 80561 in the entrance switches of Nova Zagora station on 15.05.2020

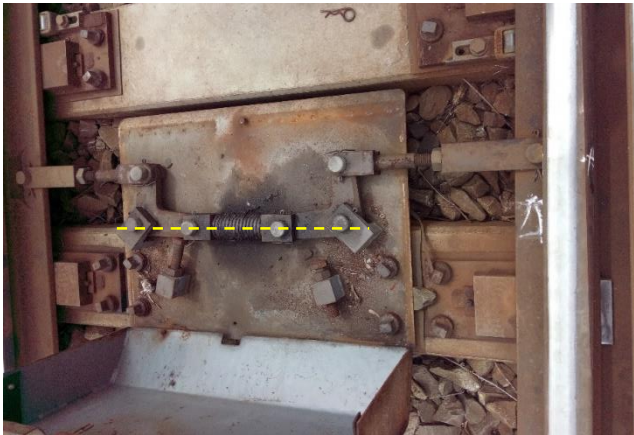
an incorrectly regulated and maintained spring rocker arm mounted on an arrow № 20, which at the time of derailment has been in an equilibrium (intermediate) position, allowing wild vibration and displacement of the tongues (Fig. 2 and Fig. 3).

Fig. 2. Switch №20 spring rocker arm, set in unregulated (equilibrium) position

After opening the cover of the spring rocker arm, mounted on switch № 20, it is visually established that it is unregulated and unmaintained. The spring rocker arm has not crossed the neutral line and has remained in an intermediate equilibrium position (Fig. 2 and Fig. 3). The measured distance between the free right tongue and the right shoulder rail in the area of the spring rocker arm is 40 mm, at a rate of 65 ± 3 mm.

3. Recommendation 3 proposes NRIC together with Voestalpine Railway Systems Bulgaria OOD to amend and supplement the "Manual for installation, operation and maintenance of a spring rocker arm with two arms", to write down the parametric data for repair and maintenance in compliance with the norms for railway switches safe operation.

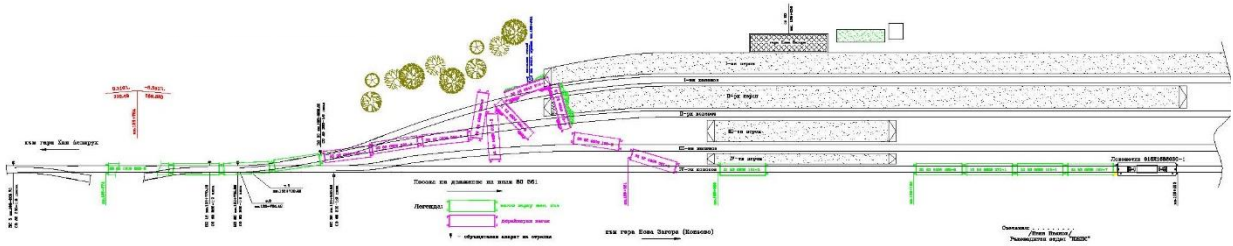
Fig. 4. Scheme of the derailed train

the load scattered between the 1st and 4th tracks, and the locomotive with the first five wagons stops on the 4th track in front of the station (Fig. 4).

suspension of the two bogies have borne off the forces of the resistances in the movement of the wagon obliquely along the ballast prism for 140.58 meters between the 4th and 3rd track (Fig. 4).

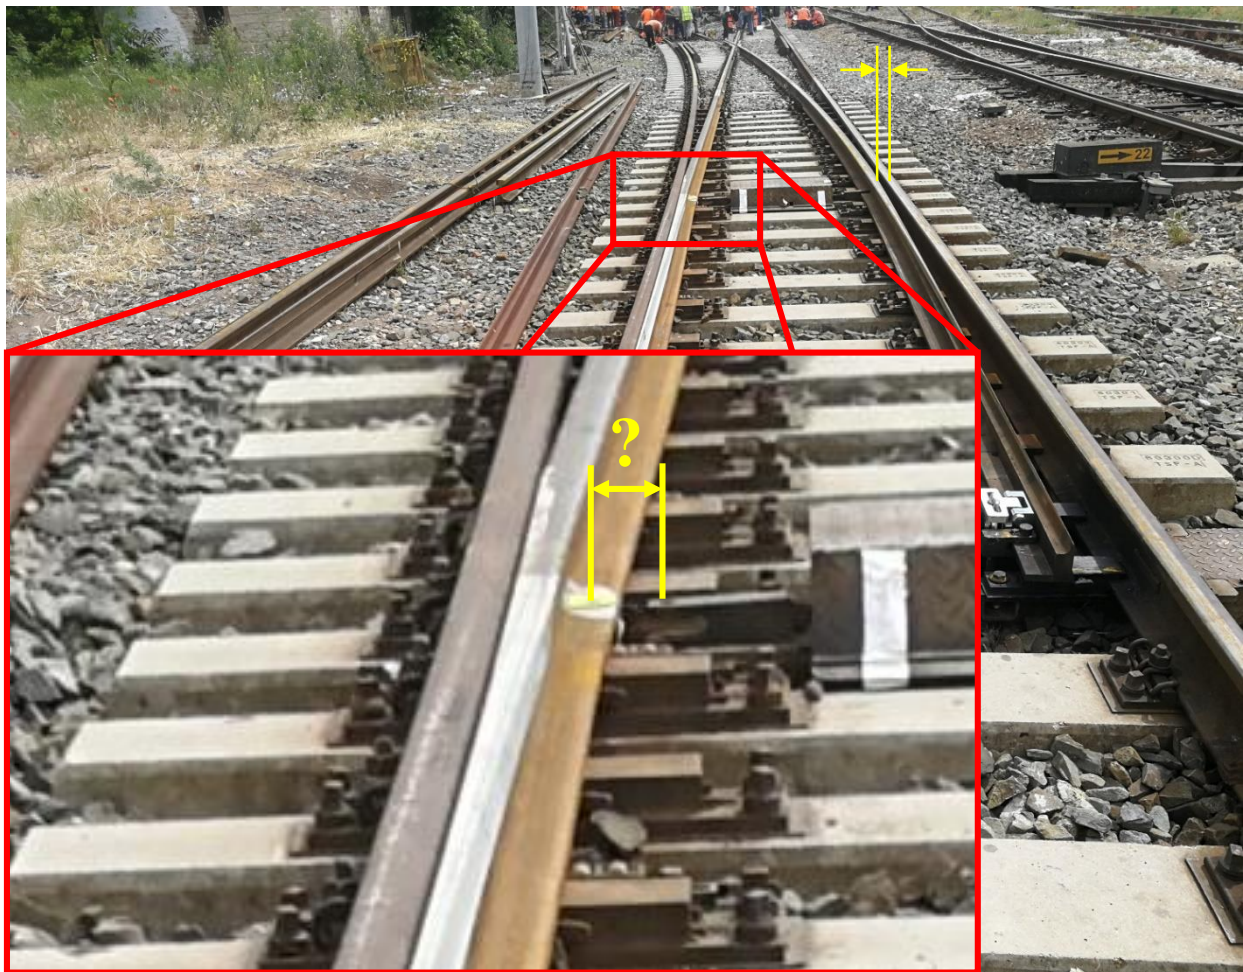
Fig. 6

On 22.05.2020 NRIC changes the left tongue and left shoulder rail of switch № 20 at Nova Zagora station (Fig. 6).

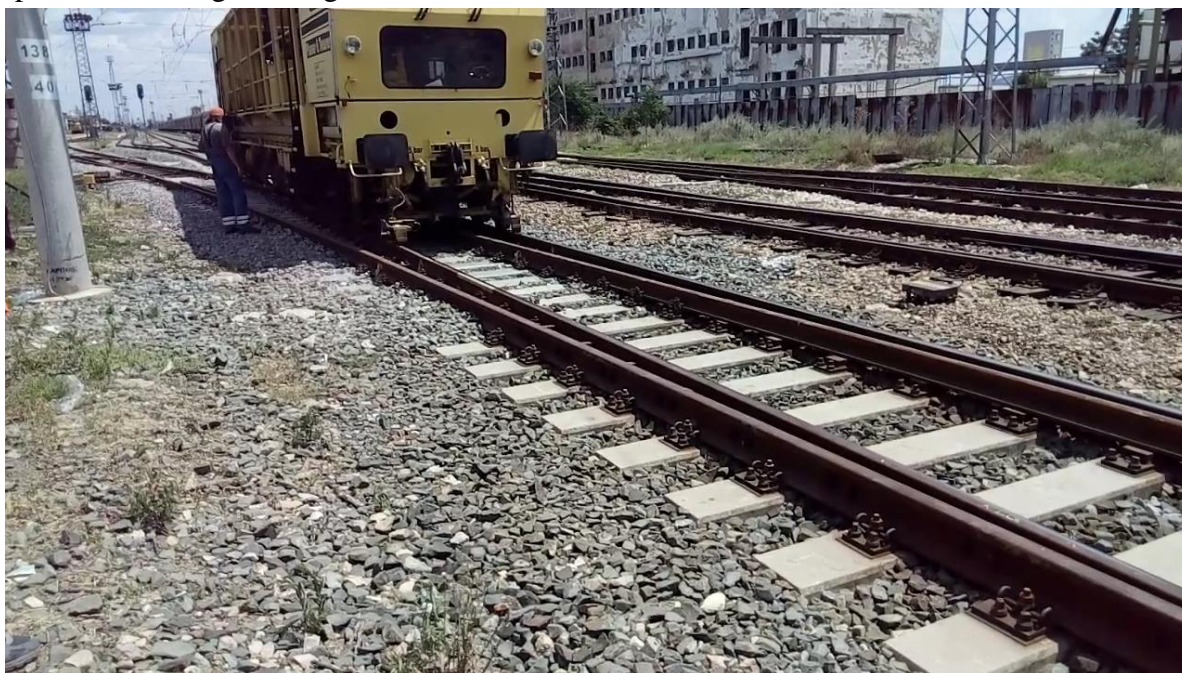
Fig. 7

On 22.07.2020, **after additional adjustments of the spring rocker arm and its normalization**, some experiments are performed with dynamic stabilizer DGS 62-2, for the main and diversion track with maximum load 100 kN and frequency 33 Hz (Fig. 7) to switch № 20 at Nova Zagora station. Three test measurements are performed in both directions, and no changes in

the technical condition of the switch are found. No switch cuts are caused in these tests. The tests are performed along the tongue of the switch.

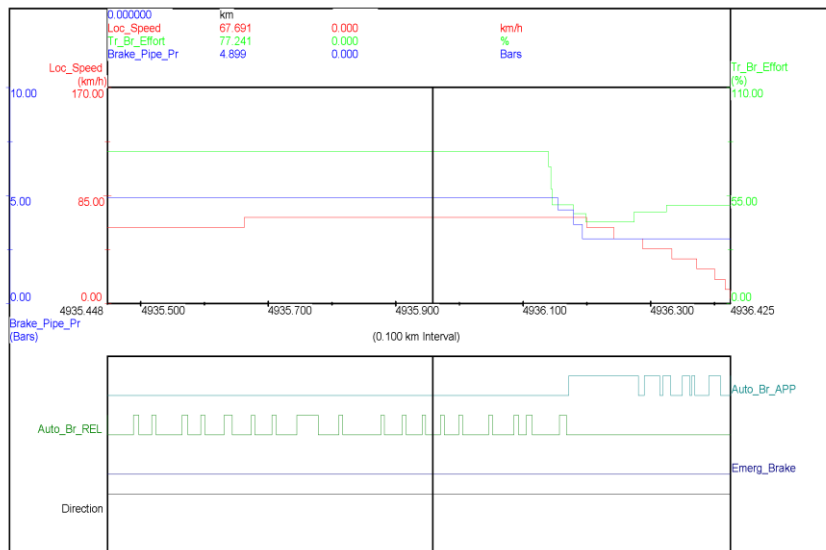
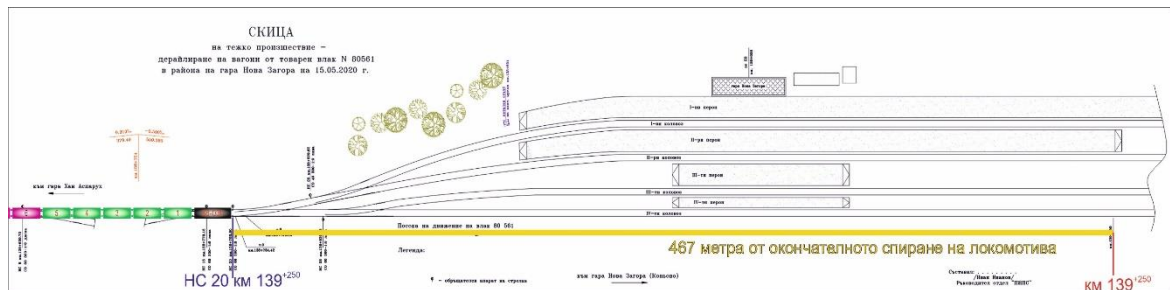
Fig. 17

2. At conditional km 4935,958 at 02:19:15 hrs (conditional time) the locomotive passes through switch № 20 (Fig. 17, Fig. 18 - the figures in green mark the wagons that have not derailed, and those in purple mark the derailed wagons).
3. The locomotive is located 358 meters from the final stop point when wagon № 33 52 080 6001-2 (the sixth in the composition) is on switch № 20 (Fig. 19). This happens at conditional km 4936,067 at 02:19:21 hrs (conditional time). The sixth car derails first with

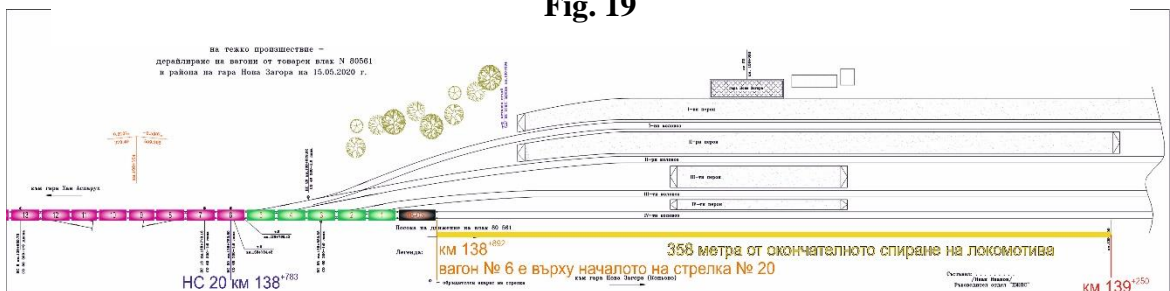
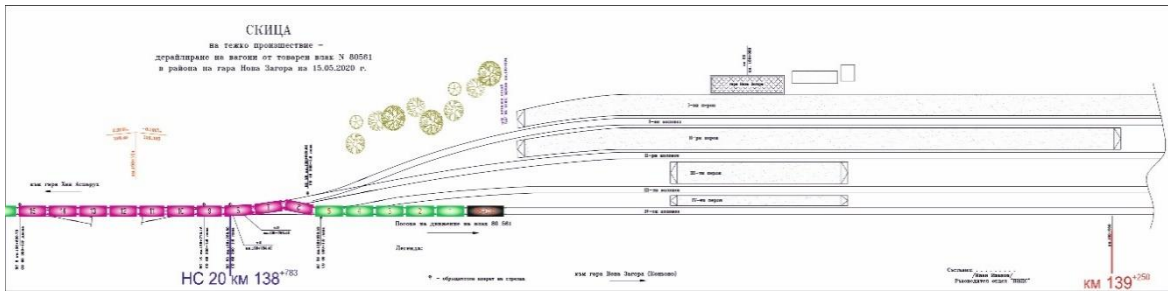
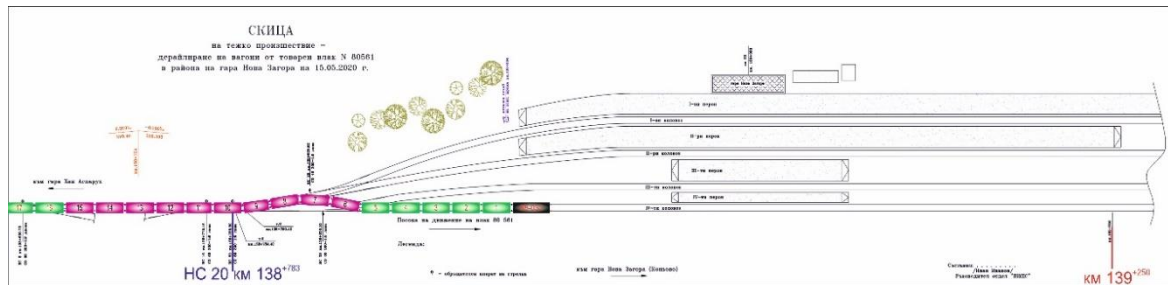
Fig. 20

the second bogie in the direction of travel (Figs. 20, 21, 22). The place where the locomotive is located corresponds to km 138 + 892 of the 8th railway line;

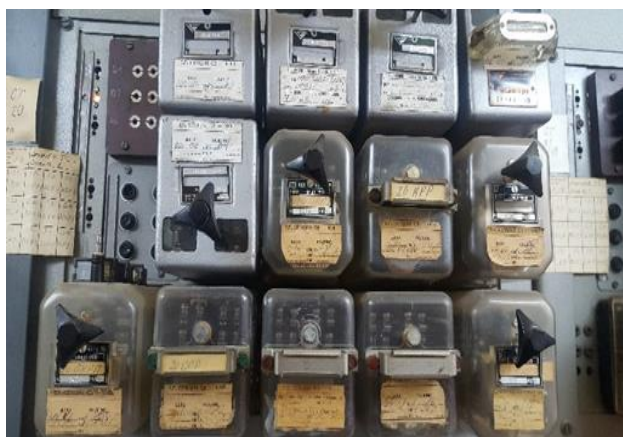
Fig. 39

During the inspection of tripod № 34 for a switch group of switch № 20, in RR, together with the bodies of DPO - Sliven it is found that the relays participating in the route are in their normal state (Fig. 39).

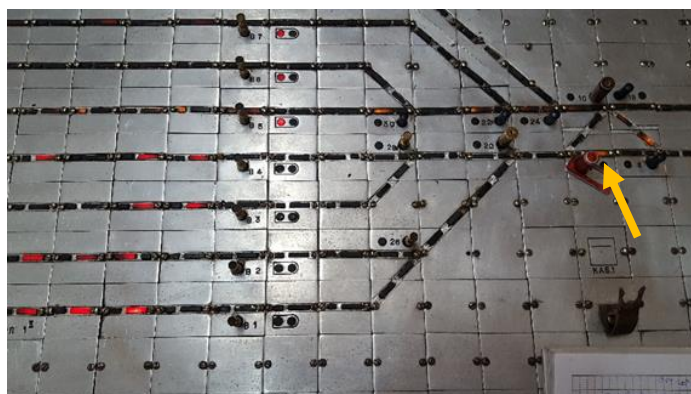
Fig. 40

When inspecting the dashboard in the office of the DHT, the indication of the status of the switch indicates a cut position. The controlled area of switch № 20 shows virtual occupancy (Fig. 40).

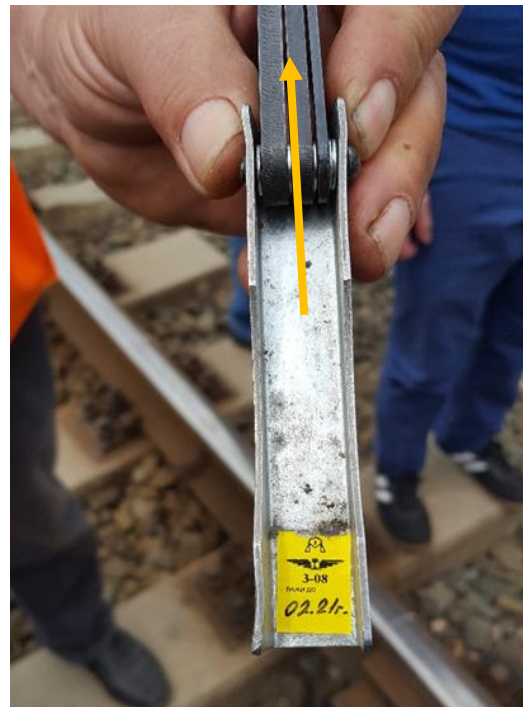
Fig. 42

- Samples were made with a calibrated template 2 mm and a template 4 mm for adhesion to the shoulder rail (Fig. 42).

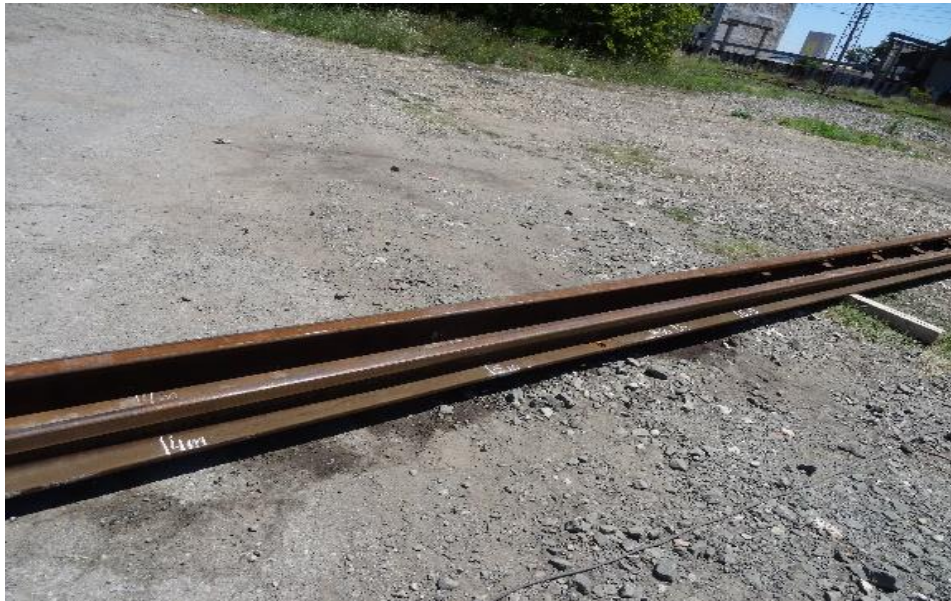
Fig. 49. General type and location of the studied element

The left shoulder rail and the left tongue of switch № 20 are located in the area of Nova Zagora railway station. Due to the prolonged stay outdoors on the surfaces of the rails, an oxide corrosion product has formed.

The studied element - the left tongue is part of the railway switch № 20, The section from the fourth to the sixth meter from the tip of the tongue has been examined. The inspection and research took place on 15.07.2020 at a place near the scene of the derailed train (Fig. 49).

On July 14, 2020, the shoulder rail and the tongue are moved from the scene of the accident to the area of the station. When moving, the surfaces of the left tongue have been severely abraded. Traces of the incision have been visible, clearly visible from the tip of the left tongue along its entire length, including the places where the examination and analysis of the surface of the tongue had to be performed (Fig. 50). The mechanical influences on the examined surface made it difficult to prepare the expert opinion on the tasks thus set.

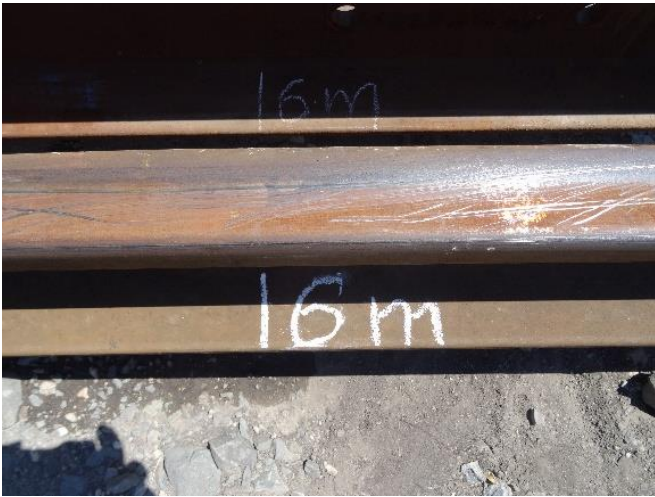
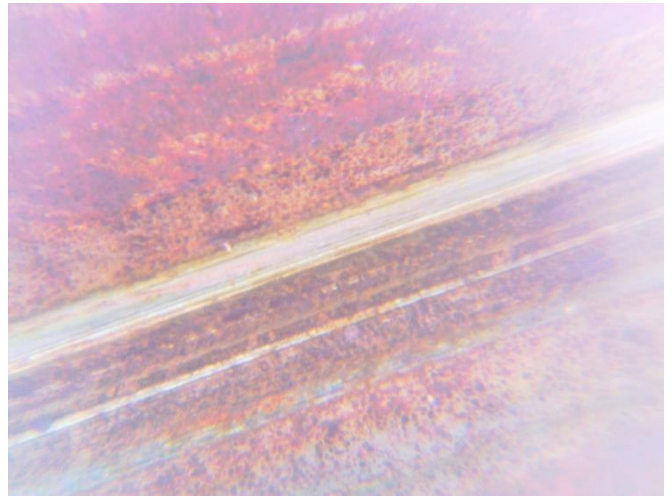
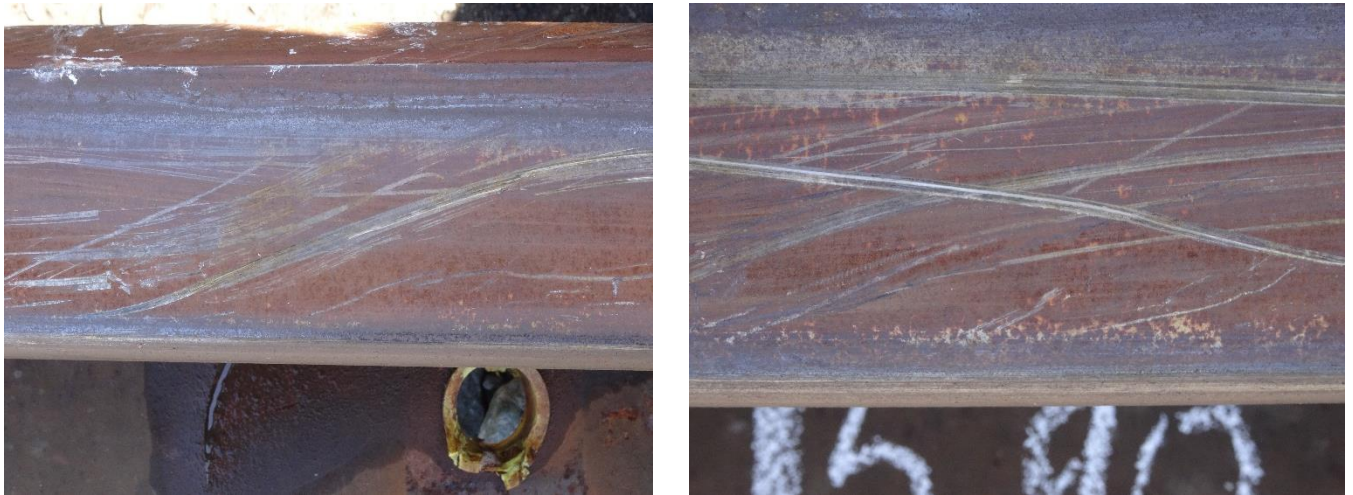
i. j.
Fig. 50. Surface of the head of the left tongue of switch № 20 between the 4th and 6th meter

Most of the traces of incision were at an angle of 60° relating to the axis of the rail (Fig. 50 a-g), but there were also such that meandered along the studied section of the rail (Fig. 50 d-g). These traces had a metallic sheen (Fig. 50 h), no corrosion products were deposited on them, which shows that they are quite fresh - obtained by moving (dragging) the tongue the day before the examination (Fig. 50 h, i, j).

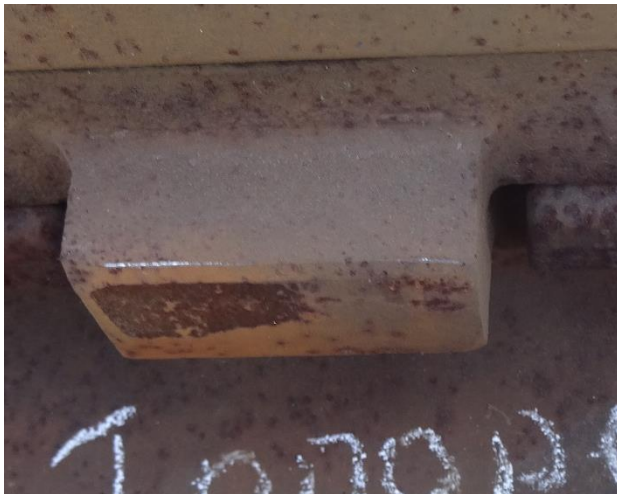
a. Support wedge I

- On support wedge I - trace of abrasion on the side of the wedge (Fig. 52 a);
- On support wedge II - traces of beating on the upper plane of the wedge (Fig. 52 b);
- On support wedge III - traces of beating of two ledges and one rim on the upper plane of the wedge (Fig. 52 c)
- On support wedge IV - traces of beating of two ledges and one rim on the upper plane of the wedge (Fig. 52 d);

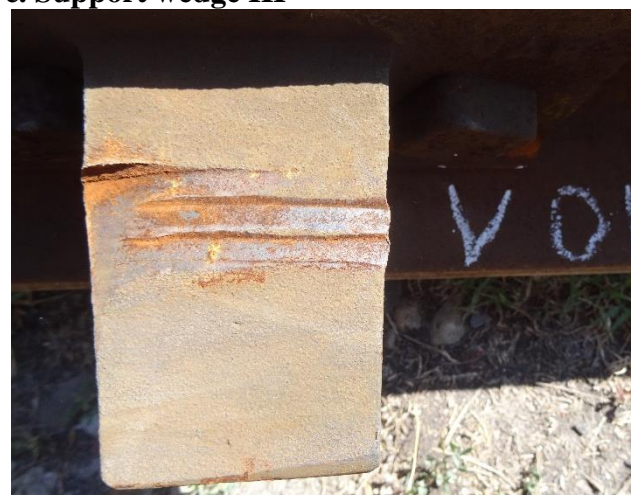
e. Support wedge V

- On support wedge V - traces of beating of two ledges and one rim on the upper plane of the wedge (Fig. 52 e);
- On support wedge VI - traces of beating of two ledges and one rim on the upper plane of the wedge (Fig. 52 f);
- On support wedge VII - traces of beating of two ledges and one rim on the upper plane of the wedge (Fig. 52 g);
- On support wedge VIII - traces of beating of two ledges and one rim on the upper plane of the wedge (Fig. 52 h);
- On support wedge IX - traces of beating of two ledges on the upper plane of the wedge (Fig. 52 i).

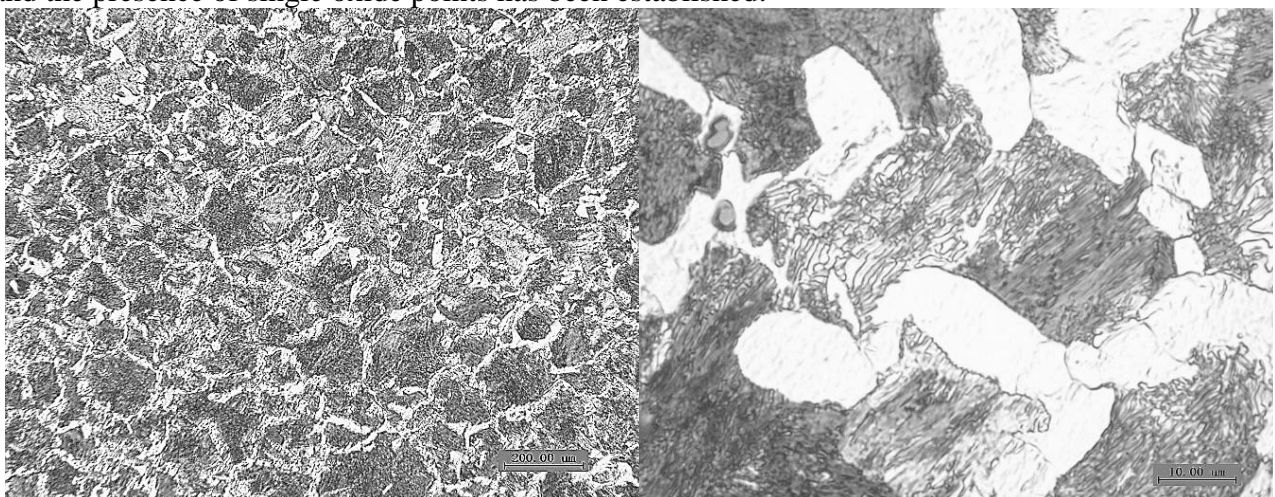
Fig. 53 Steel microstructure, OM.

It was found that the microstructure of the metal is pearlitic-ferritic (Fig. 53). The percentage of the amount of perlite to the amount of ferrite is % P, /% F = 65/35. The dispersion of lamellar perlite corresponds to grade 6 - medium-lamellar perlite with a distance between the plates of 1µm. The grain size is grade 2. An assessment of the non-metallic inclusions in the steel has been performed and the presence of single oxide points has been established.

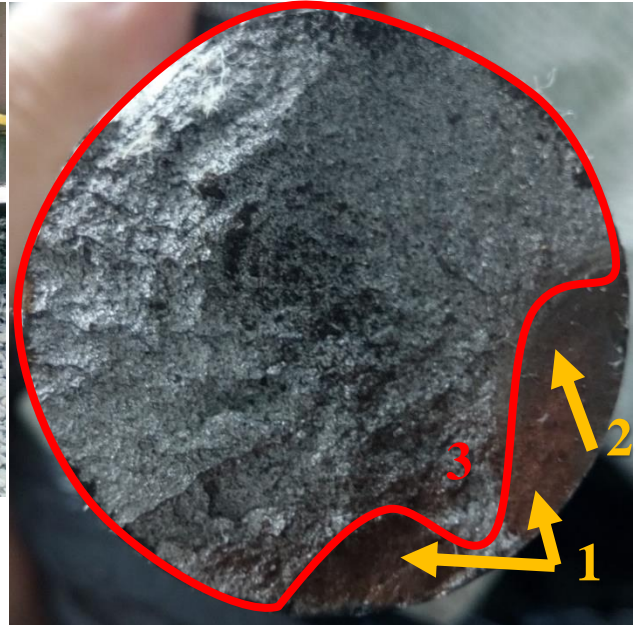
Fig. 62

1. Wagon № 33520806001-2 - sixth of the composition: the first derailed wagon (Fig. 60). Positioned between the third and fourth tracks, derailed with the four wheels, with deformed rear frontal beam and punctured transverse wall of the basket due to the impact of the seventh car, damaged bogies and wheels, loose bolt on the front screw coupling (to the fifth car), broken spring bolt on the rear earring of the first bogie of the first wheel on the left side, according to the direction of movement (Fig. 61). A brief analysis of the condition of the fracture after the disruption of the spring bolt: the structure of the fracture clearly shows the presence of the characteristic fracture zones due to fatigue of the material. A fragile disruption is observed in the base part of the section, characterizing sudden destruction by excessively high sudden loads, many times exceeding the nominal ones for the respective section (Fig. 62, pos. 3).

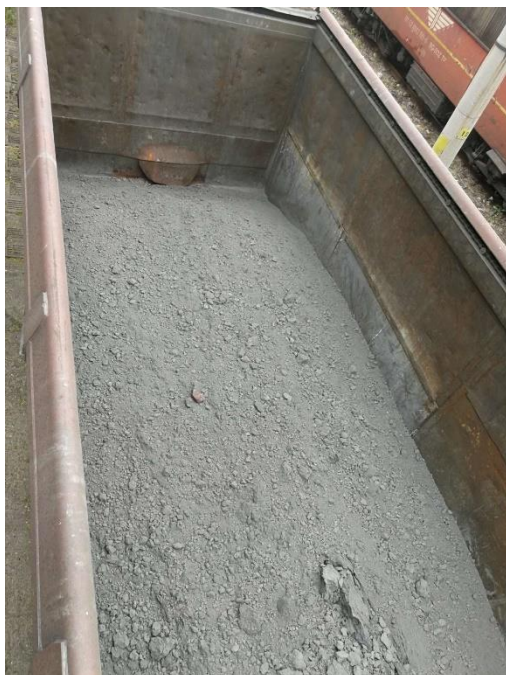
Fig. 65.1

- ✓ After the derailment the bogies of the wagon are replaced;
- ✓ Undercutting is found on the wagon basket in the area above the buffer, which confirms the conclusion that the 7th wagon with one of its buffers has hit the 6th wagon;
- ✓ It has been established that there is a so-called "Slope" in the rear of the floor of the wagon, which is at a certain slope, i.e. the floor area of the wagon is not tightly filled. It is obvious that as a result of the impact the bulk cargo has moved forward and to the right in the direction of travel;
