**REPUBLIC OF BULGARIA**  
**NATIONAL AIR, MARITIME AND RAILWAY ACCIDENTS**  
**INVESTIGATION BOARD**

**FINAL REPORT**

**Investigation of railway accident – derailment of locomotive № 46041 of direct freight train № 30682 while entering in Kostenets station on 15.07.2020**

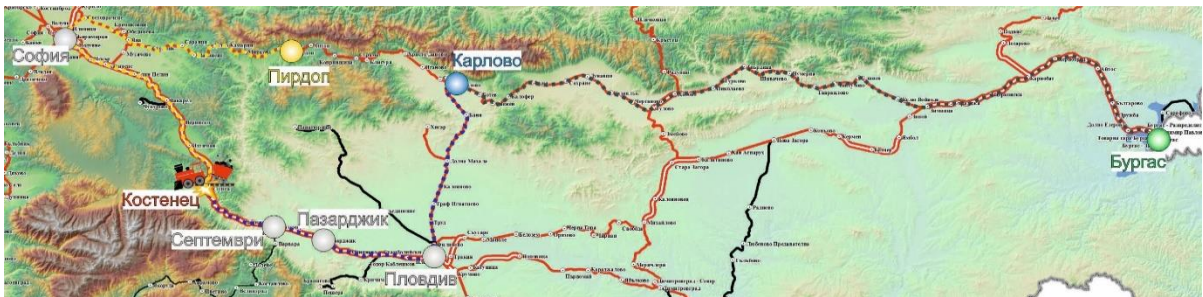
**Fig. 1.1. Traffic route of DFT 30682**

The accident happened during the entrance of DFT No 30682 on third acceptance-departure siding track at Kostenets station in the curve after switch No 15 at 09:50 a.m. (fig. 1.1).

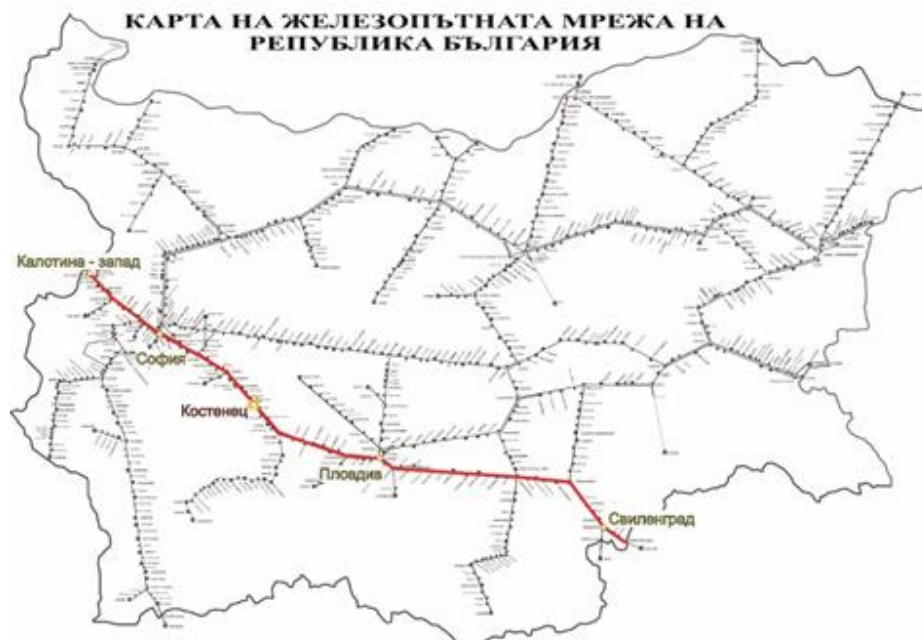
Фиг. 3.1.

Kostenets station is located at kilometre 74+349, between the stations Belovo and Ihtiman. There are five tracks in the station; four of the tracks are acceptance-departure tracks. The station is located along the first main railway line in direction Kalotina-West – Sofia – Plovdiv – Svilengrad – Republic of Turkey. The first main railway line is a conventional line with traffic speed up to 160 km/h (Fig. 3.1).

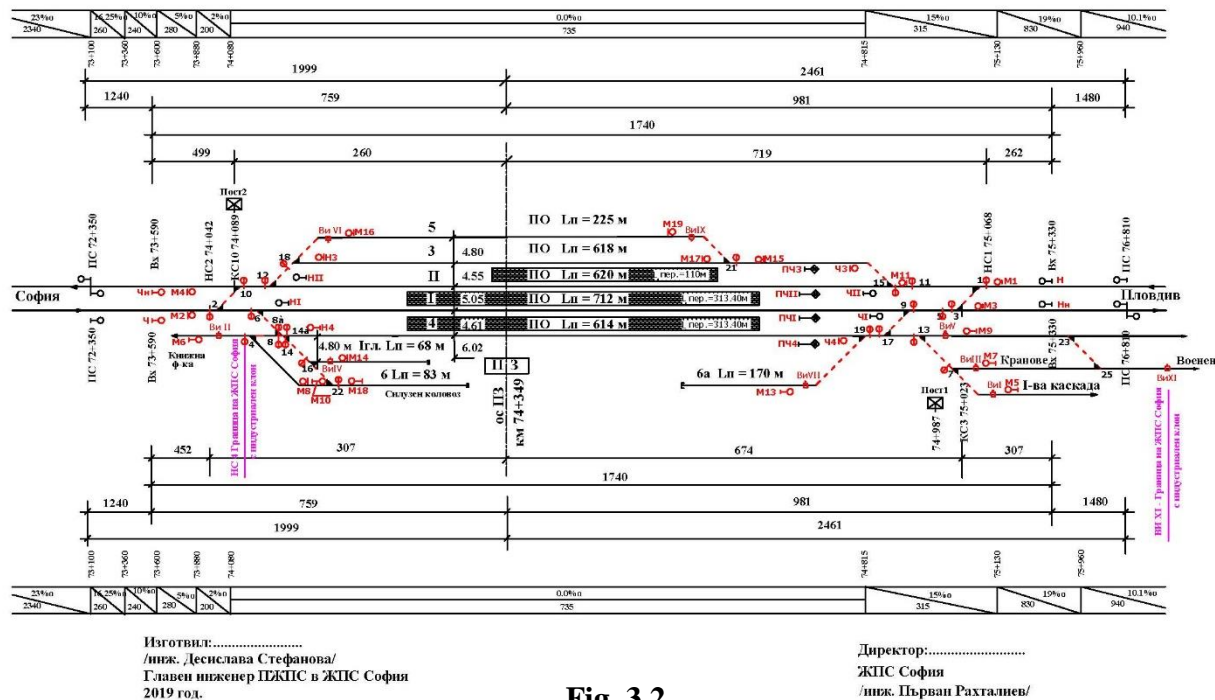
Fig. 3.2.

- Third acceptance-departure track in Kostenets station is with total length 618 meters, with cant from km 74+080 to 74+815 – 0 ‰, and then follows downhill inclination 15 ‰ in direction to Belovo station, equipped with exit signals on the speed signalling, included in the safety installation of the station, with overhead contact line/catenary (fig. 3.2).

- By recommendation 4 it is suggested SE NRIC to adjust third track in Kostenets station in accordance with the requirements of item 3.3.6 and item 3.3.12.7 stipulated in Instruction on the layout and maintenance of the rail track superstructure and rail switches (for counter-curves without cant without transition curves and without intermediate line).

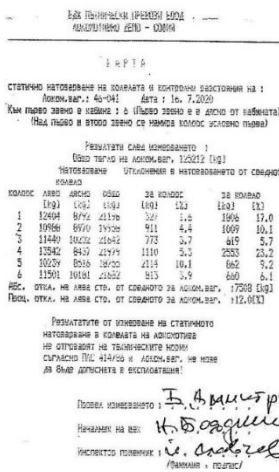
Fig. 4.8.

On 16.07.2020 in Plovdiv locomotive depot were performed three control measurements of the static load of the locomotive wheels under axles (fig. 4.8, 4.9 and 4.10), as the obtained results do not respect the technical norms.
