FINAL REPORT

Investigation of a serious incident, occurred on July 18, 2017 at Burgas Airport, Bulgaria, by AIRBUS A320-232, registration marks SX-ORG, operated by ORANGE2FLY

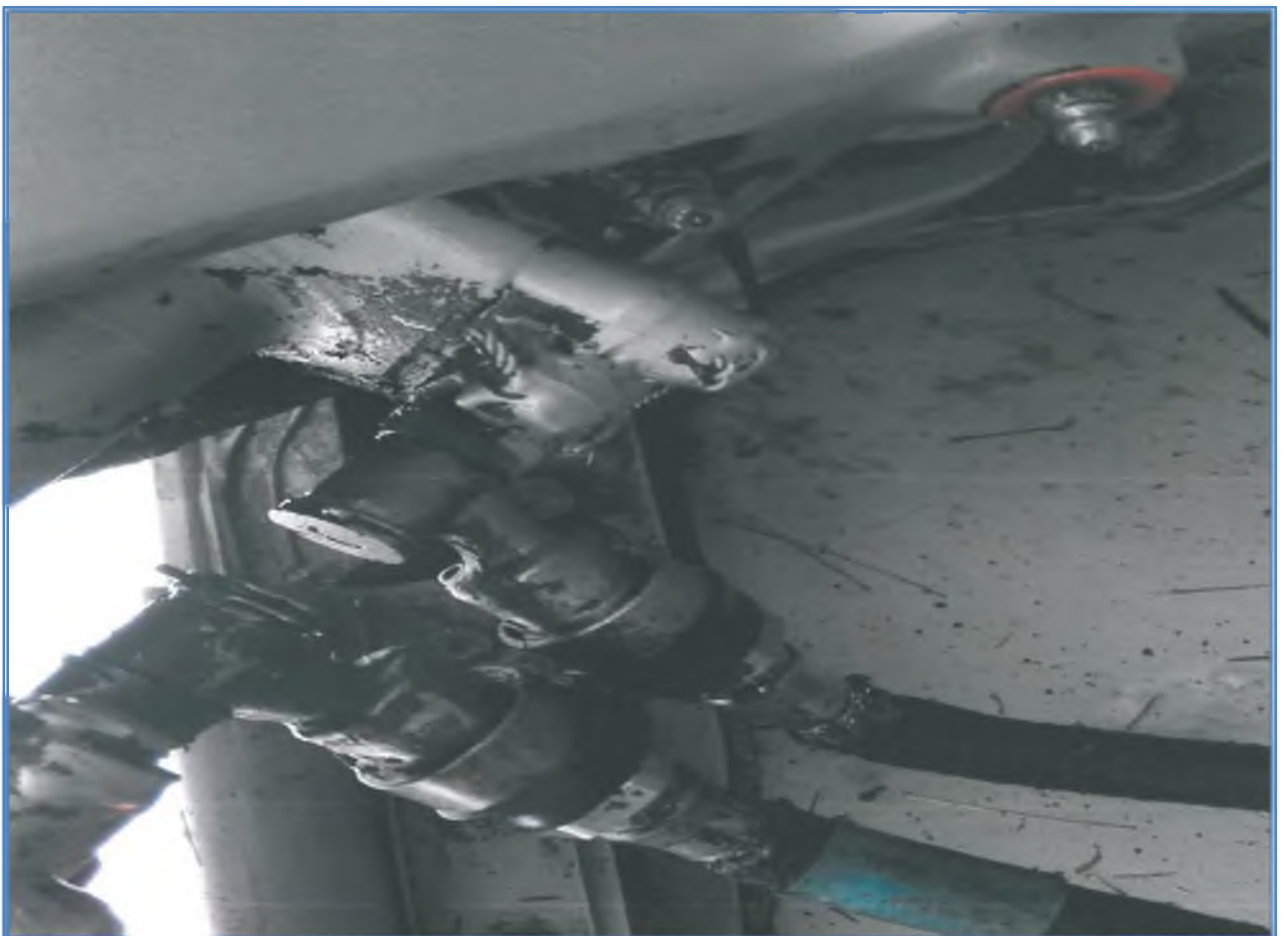
Fig. 6

- A slot of 800 mm in length and 20 mm in outboard Fan Cowl of engine No1 (Figure 4 of Appendix 1) caused by a collision with taxiway indicative sign when the aircraft exit the RWY (Figure 3 of Appendix 1);
- R/H MLG Downlock actuator flexible hoses external leak (Figure 6 of Appendix 1);
- Traces of leaked hydraulic fluid from Green hydraulics in the right main landing gear bay (Figure 6 of Appendix 1);
- Cut tyre protector from wheel № 4 of the main landing gear while passing through a side-marker lamp from RWY lights system (Figure 7 of Appendix 1);
- Contamination with grass and mud on the landing gear, wings and tail due to the movement of the aircraft on the ground outside the runway, Fig. 8 of Appendix 1.

The technical failures could result in RWY excursion in landing roll phase. Such are failures of components of flight control systems on the ground, which could happen also during the flight. During the post flight inspection, a leakage of hydraulic fluid was found in the area of the right-hand main landing gear bay, caused by a broken hose of the Green hydraulics, feeding a locking cylinder for the right-hand main landing gear, Fig.5 and Fig.6 of Appendix 1. This directed the Commission to a depth analysis about Green hydraulic system failure causal relationship for direct influence to aircraft control during the landing phase.
