FINAL REPORT

the Commission for Investigation concerning the serious incident (Airprox) involving the Boeing B737-800 aircraft, registration marks OK-TVM, operated by Travel Service a. s., and the Airbus A321-200 aircraft, registration marks G-TCDG, operated by of Thomas Cook Airlines Ltd., on 23 July 2019 in the controlled air space of the Republic of Bulgaria.

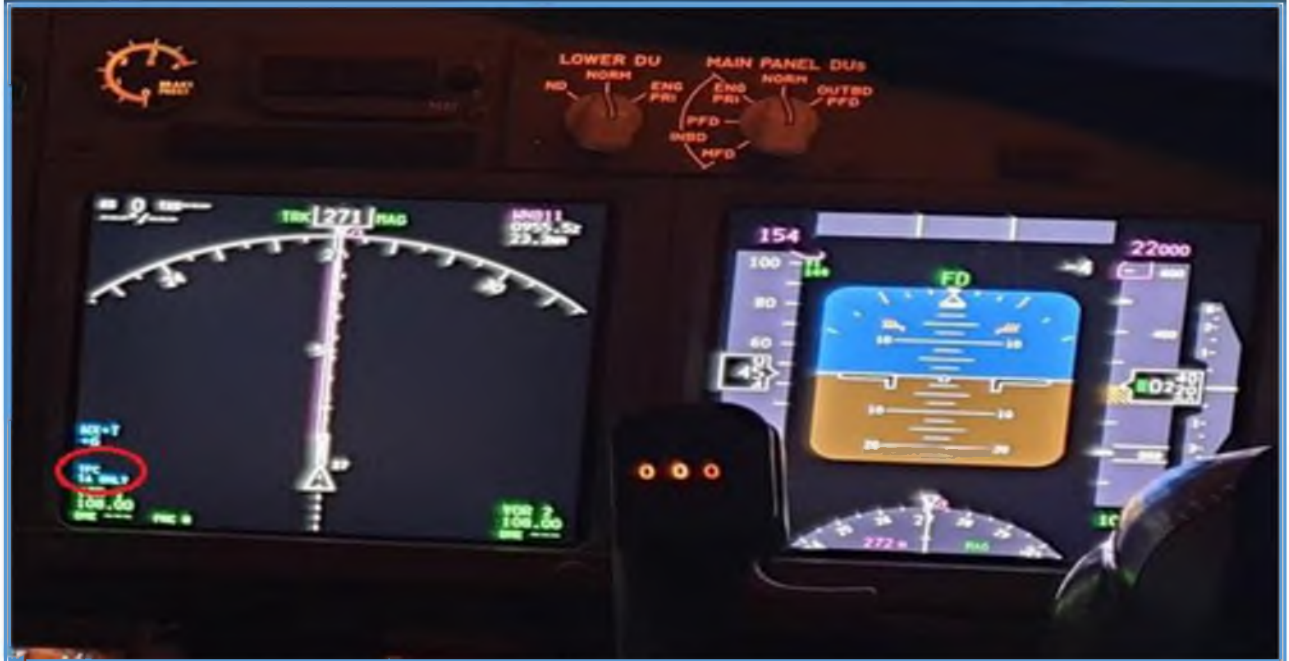
fig.10

After flying over TOTKA point TCAS detected an intruder.

On FL 204 the TCAS was activated in mode TA, as a result on both navigation displays appeared a radar sign at 02 O'clock in yellow, the visual indication „TRAFFIC” and an audible warning signal for dangerous approach of an aircraft, thought the repetition of the word „TRAFFIC TRAFFIC“. TCAS did not active in mode RA, because of a prohibition.

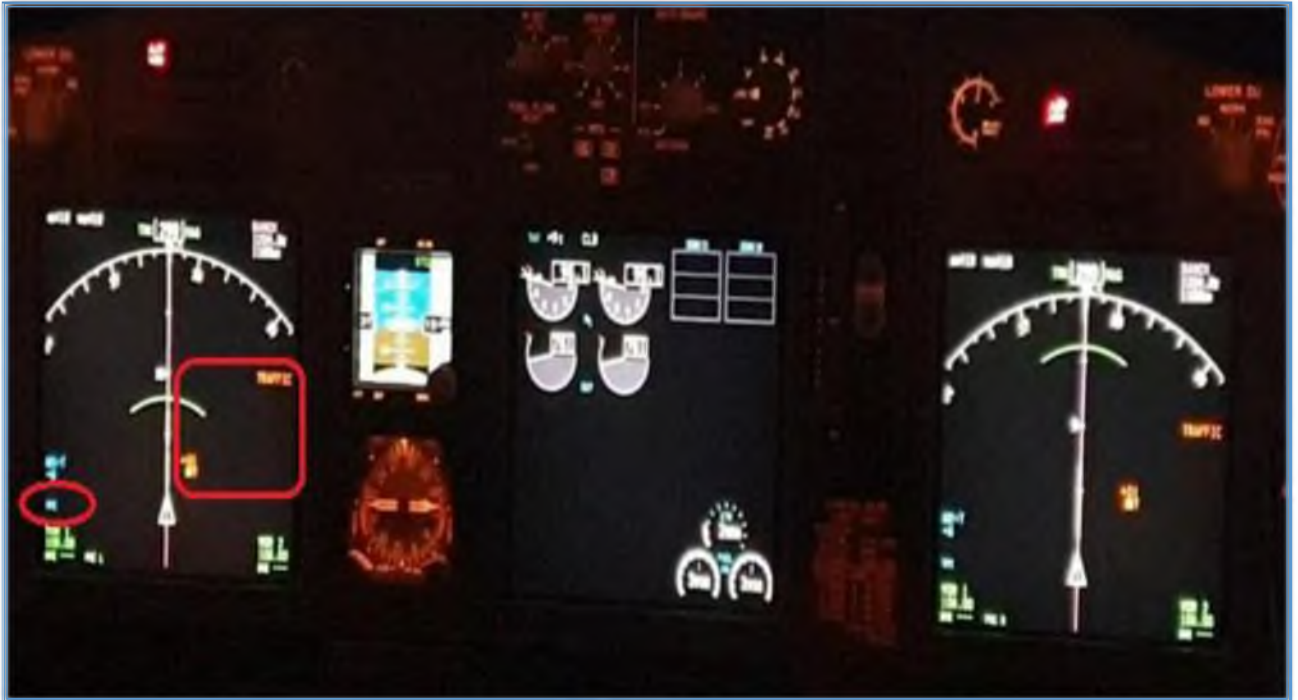
Fig.12

The flight crew immediately executed the issued commands and the conflict was resolved.

After solving of the conflict and avoiding of the collision, the system announces conflict free overcoming of the dangerous approach through an audible message “CLEAR OF CONFLICT”.

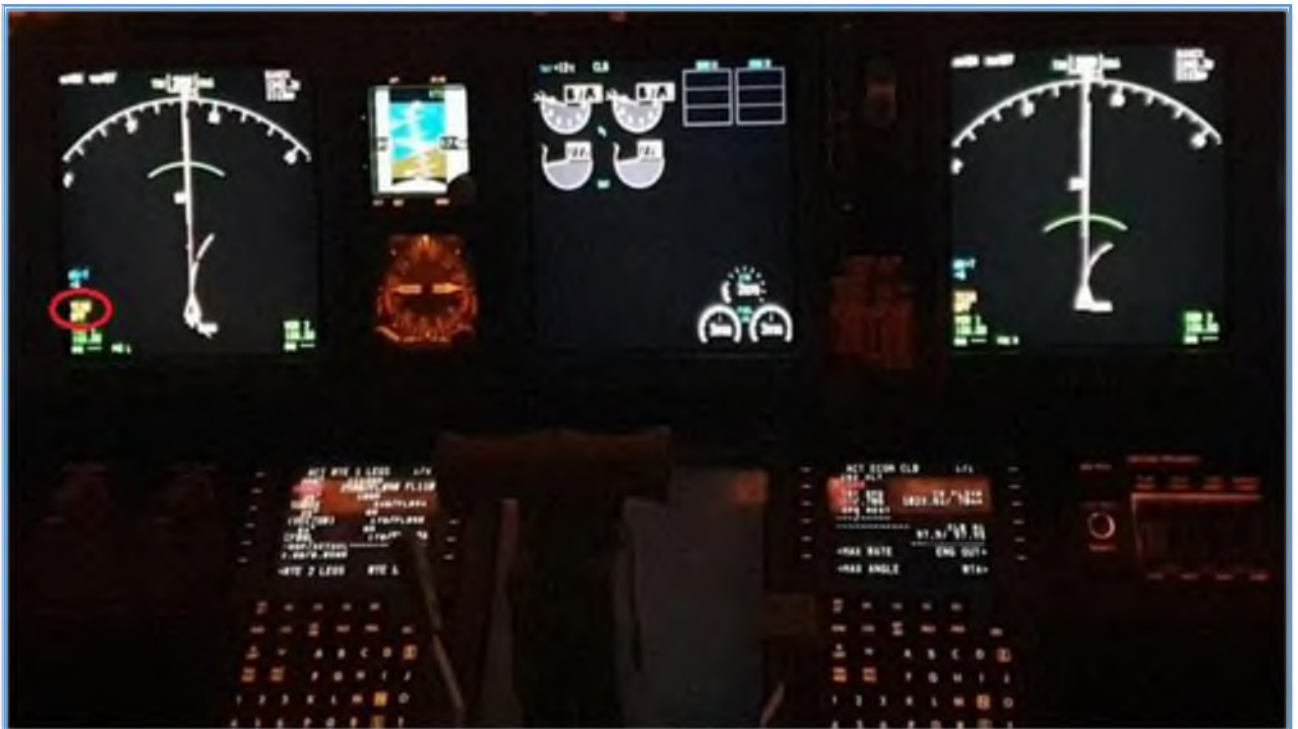
Fig.13

- Before take off from LBWN runway the flight crew set the system to the „XPNDR(ALT-ON)“ position

On both navigation, pilot displays (ND) were appeared the symbol **TCAS OFF**. This is an indication that TCAS had not provided surveillance and control in the surrounding air space. In the present case this led to the fact that the flight crew visually detected the conflict traffic.
