**Aircraft, Maritime and Railway Accident Investigation Directorate
Maritime Accident Investigation Unit**

FINAL REPORT

**Investigation of a serious marine accident –
FIRE IN THE SPACE BETWEEN QUAY AND SHIP BOARD AND
EXPLOSION IN BALLAST TANK OF M/T "VF TANKER 7" IN THE
PORT OF SPECIAL PURPOSE "TEREM - KRZ FLOTSKI ARSENAL -
VARNA"**

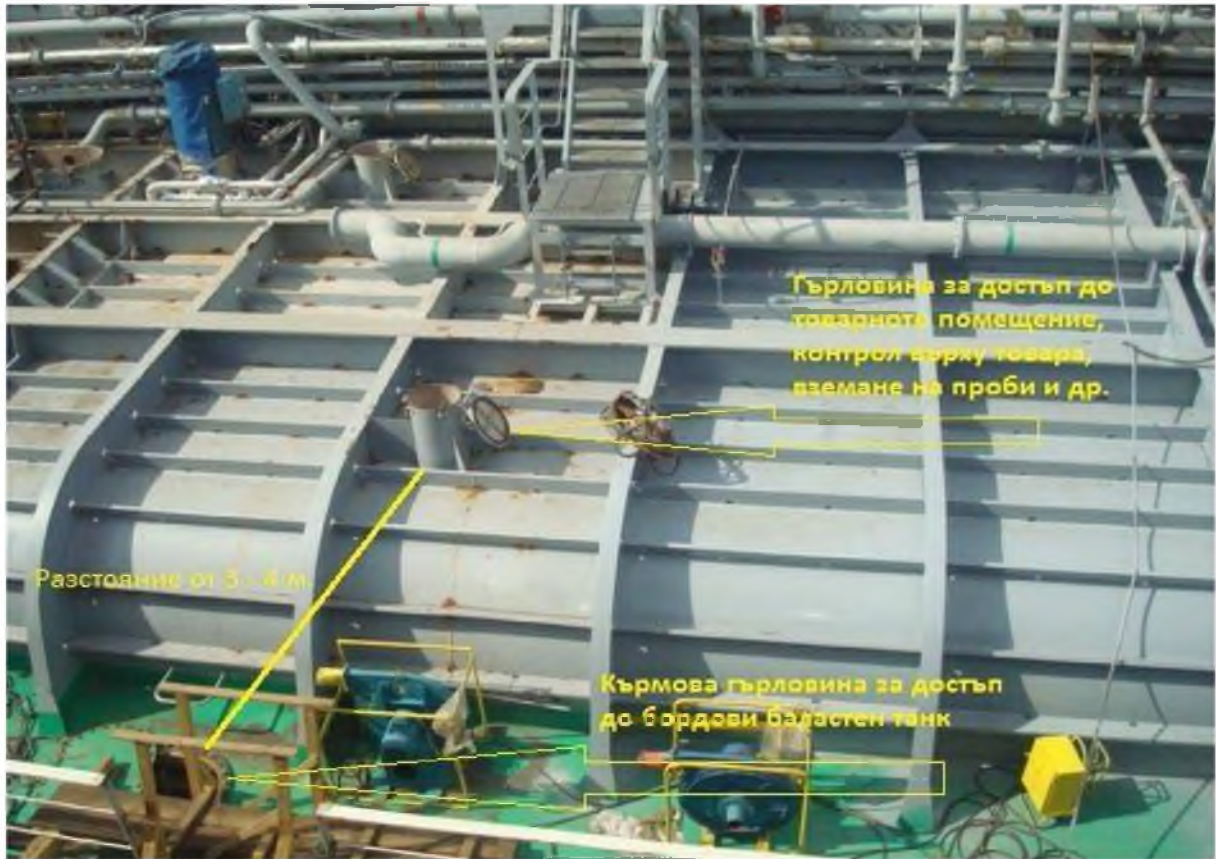
Fig. 12

1. Both ballast tanks do not physically contact a slop tank (Fig. 12).

For an unregulated fuel transportation in ballast tanks would also facilitate the location of the man holes for access to the upper deck tanks and the distances of 3-4 m between them (Fig. 12). In the case of cargo smuggling, the fastest and easiest option for doing this is by a transferring pump similar to that in Fig. 13, found on board, from a cargo tank, in an on-board ballast tank. The transfer could be accomplished by the cargo access hole through which cargo is controlled to the ballast tank access man hole on which there is a ballast control hole (Fig. 14). The smuggling version gains even greater weight than the very nature of the cargo and its physicochemical properties - it does not dissolve in water and stay on the surface of the water when mixed. i.e. smuggled quantities may be the result of residuals from previous voyages.
